# TALL TREES WELL SITE

API# 97-03707

Site preparation from beginning  
To well production

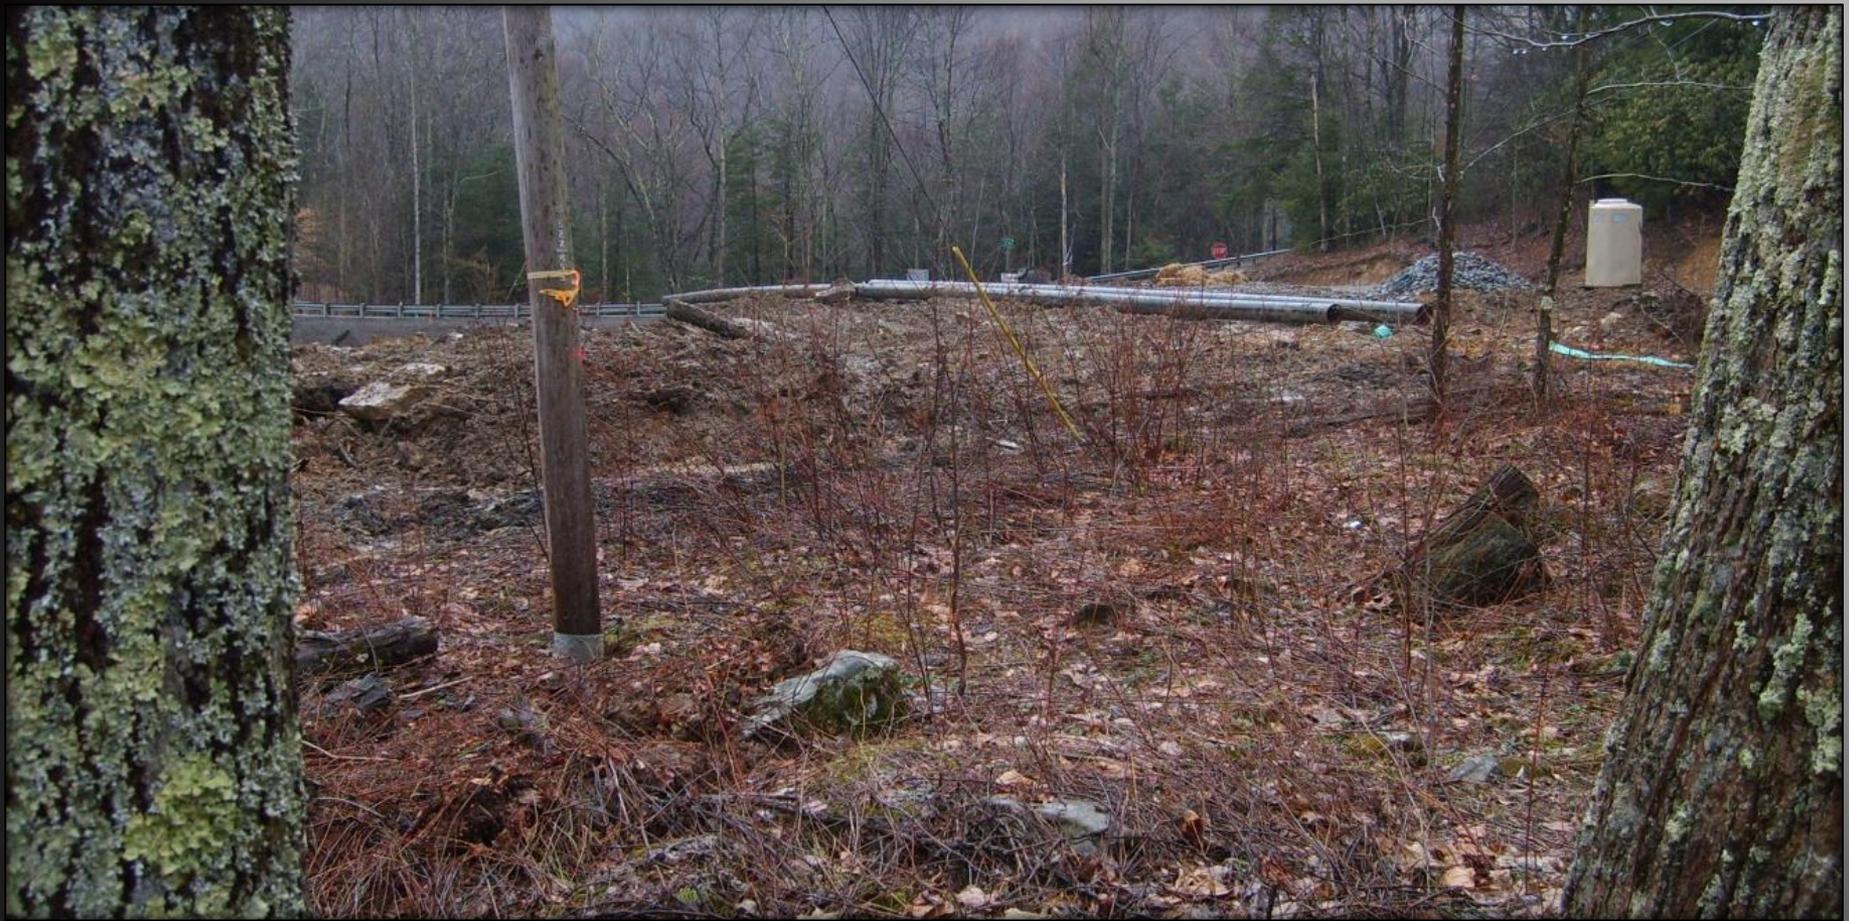
When it just looked like a timber job >>>

Note the two extra long pipes  
At the timberline in the background is RT 20

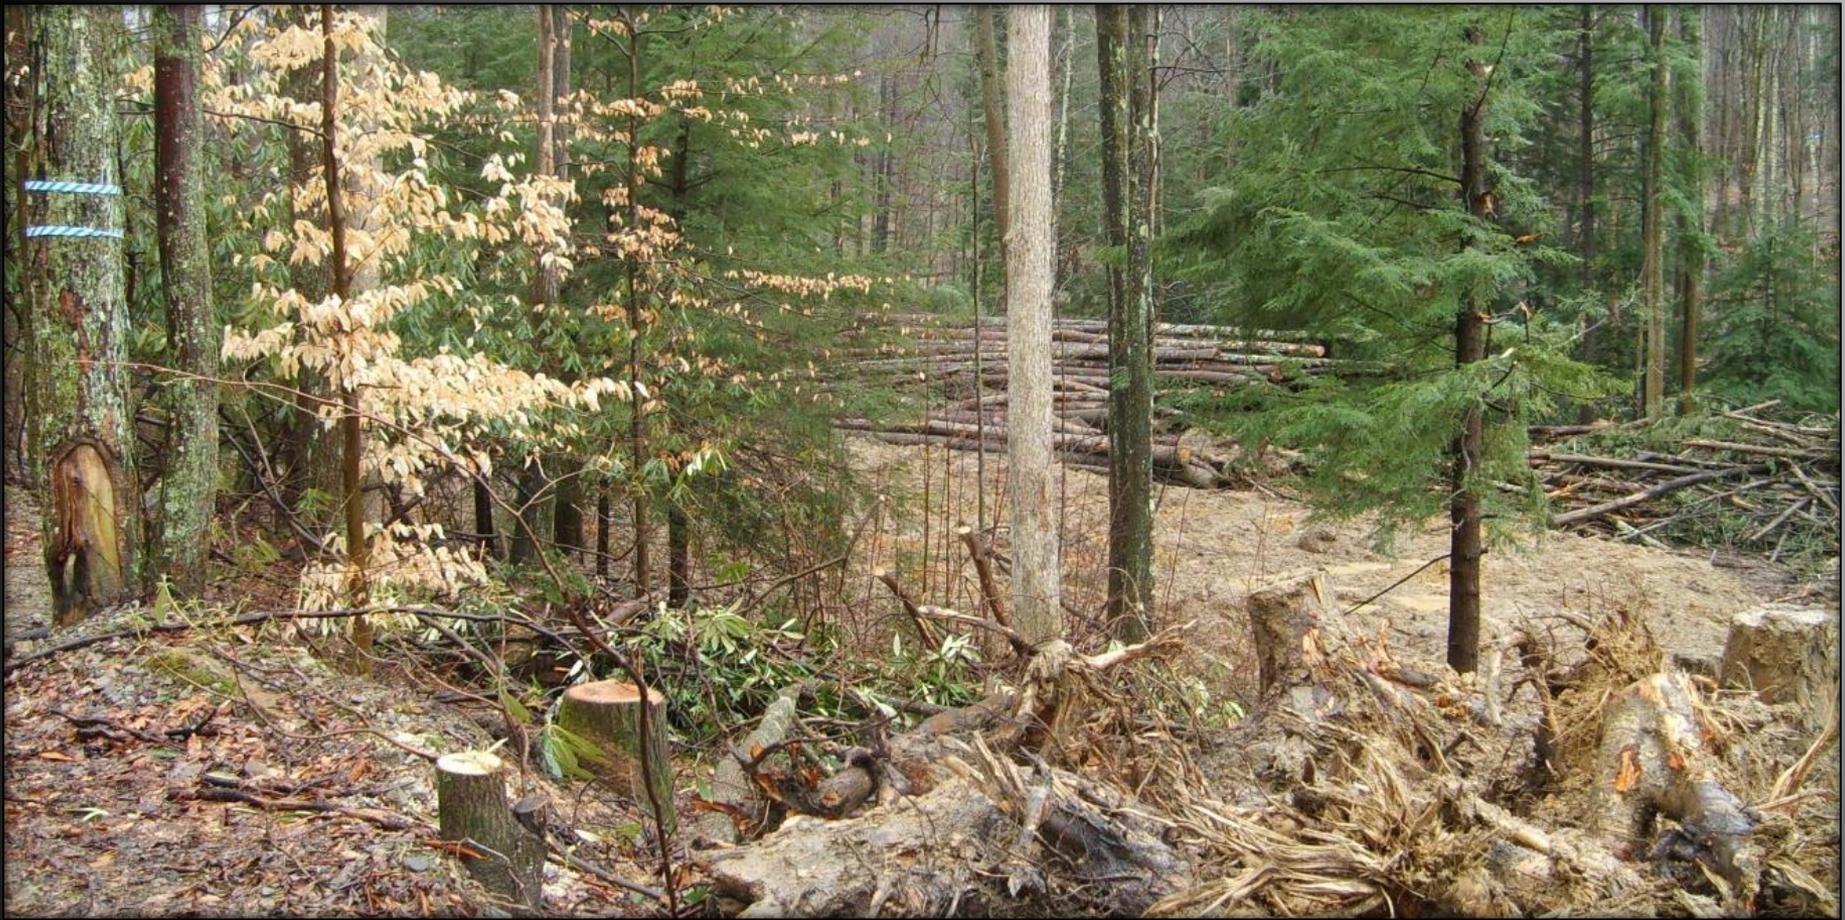
## Stacked Timber at far end of job site >>

Timber was stacked in a location that would make it difficult if not impossible to remove and get to market. The hump on left was at the road, this area later became the pipe line

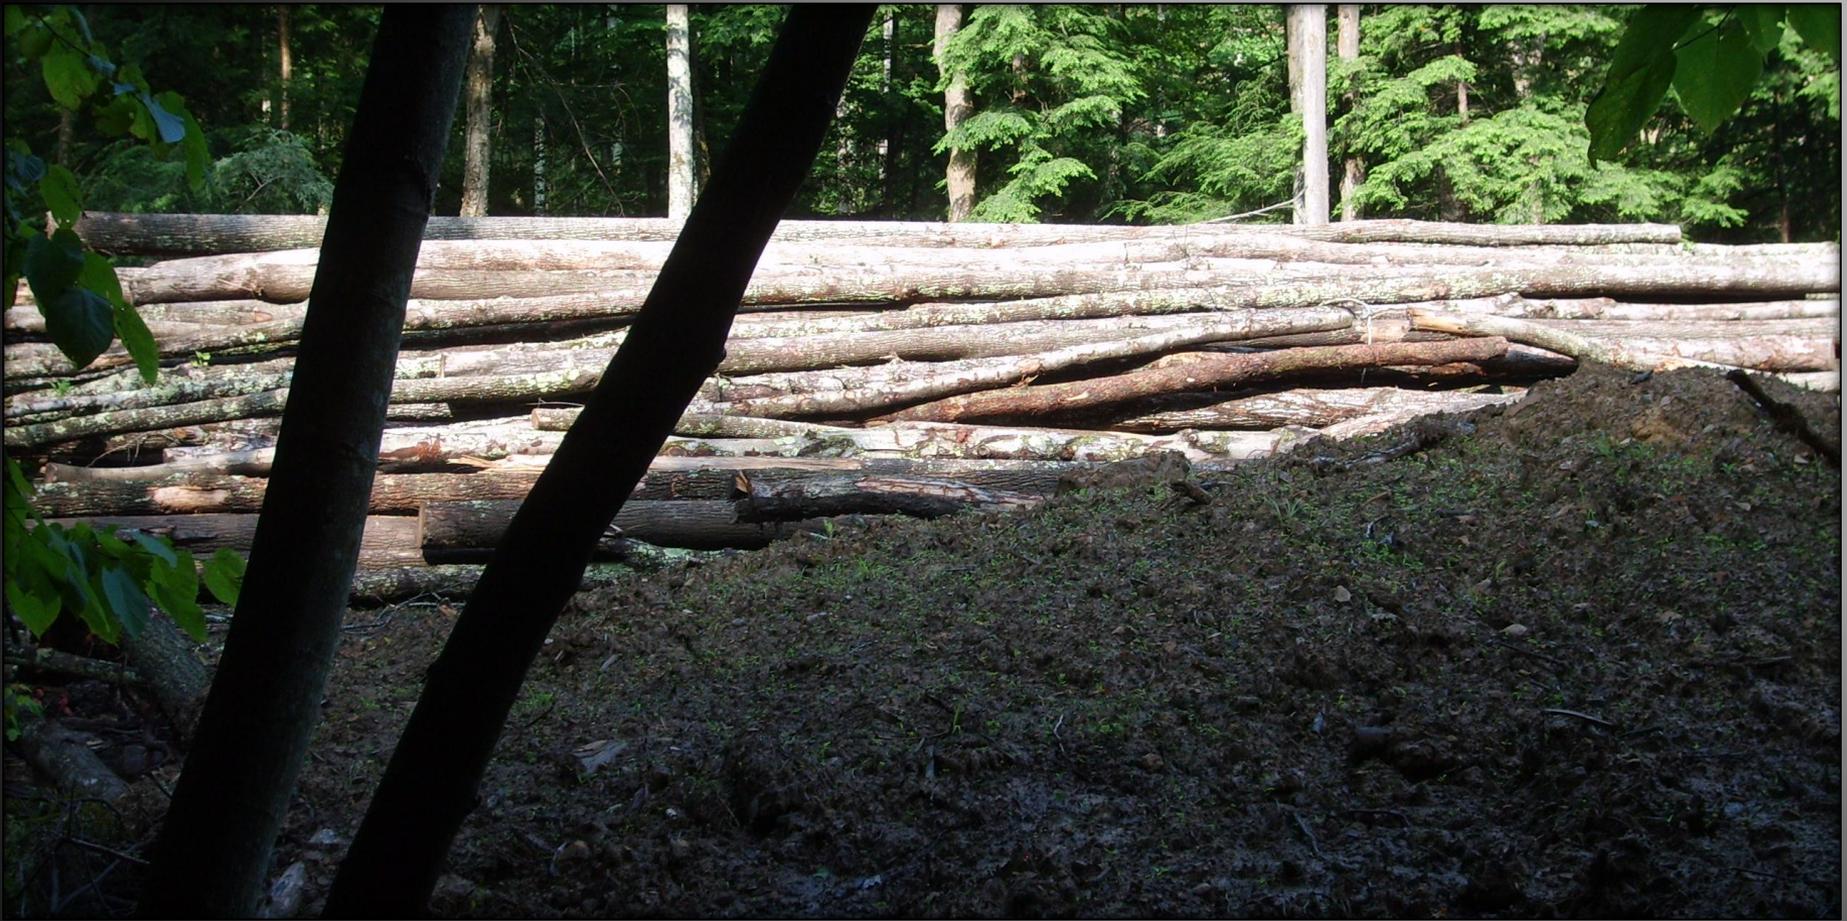
## Horizontal Tall Trees >>

There was a lot of marketable timber on this site

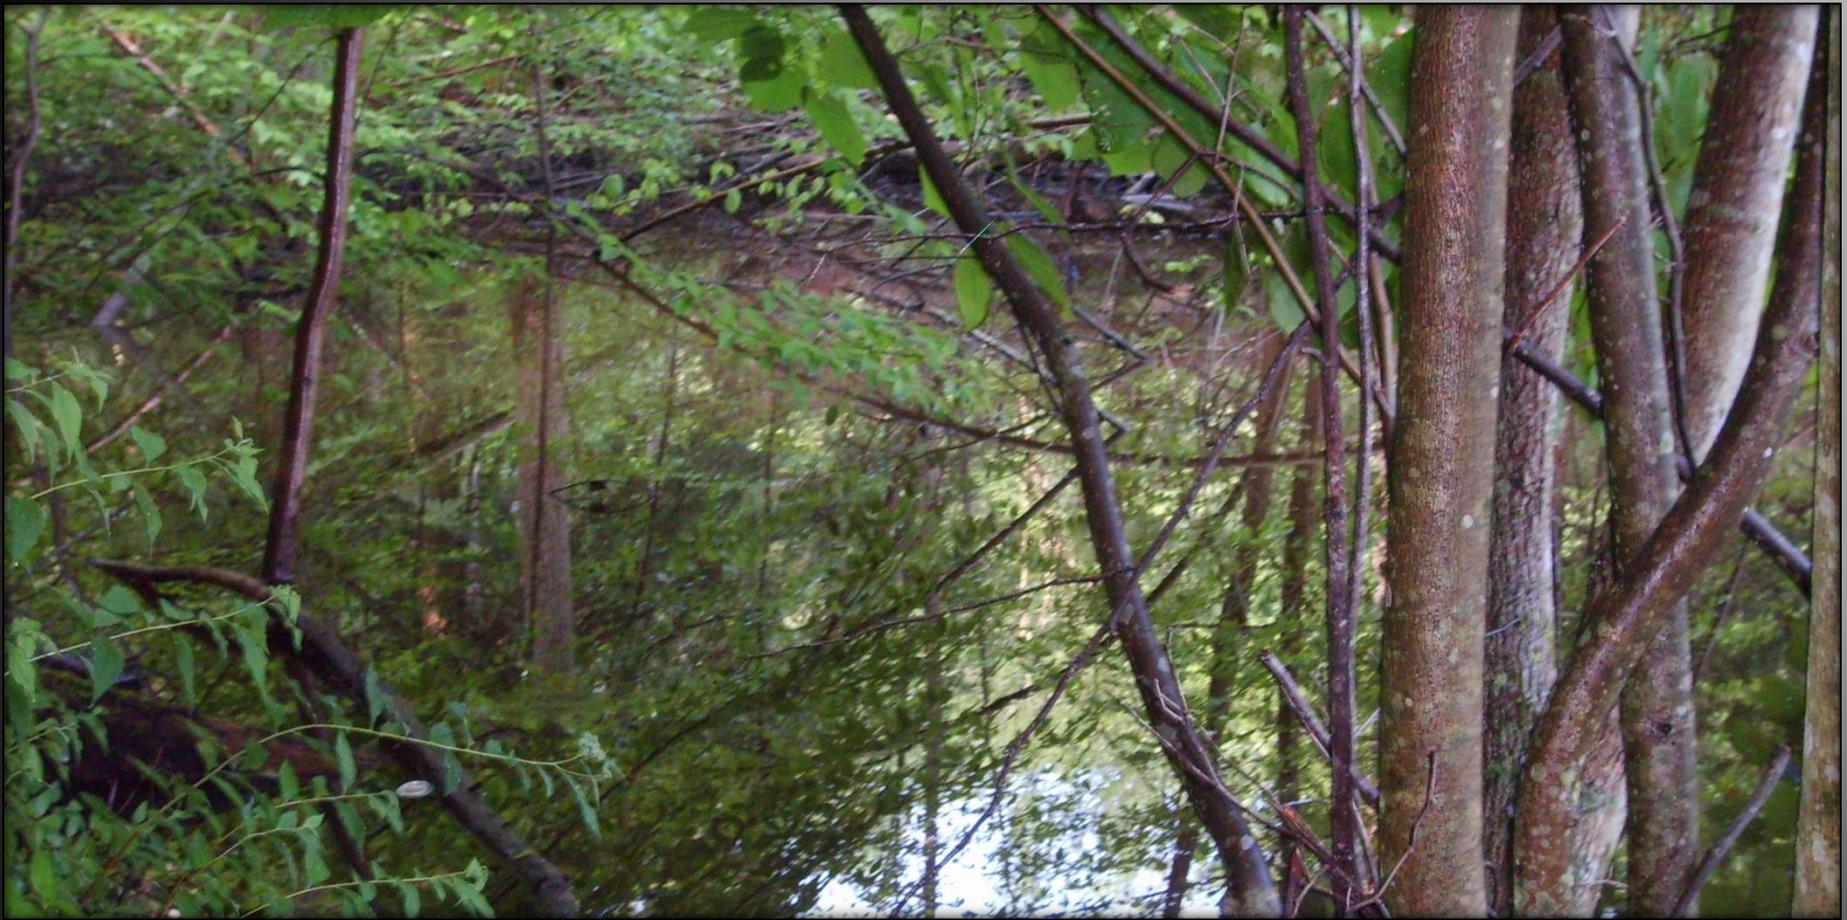
## Marsh land >>

This is upstream of where the timber was stacked

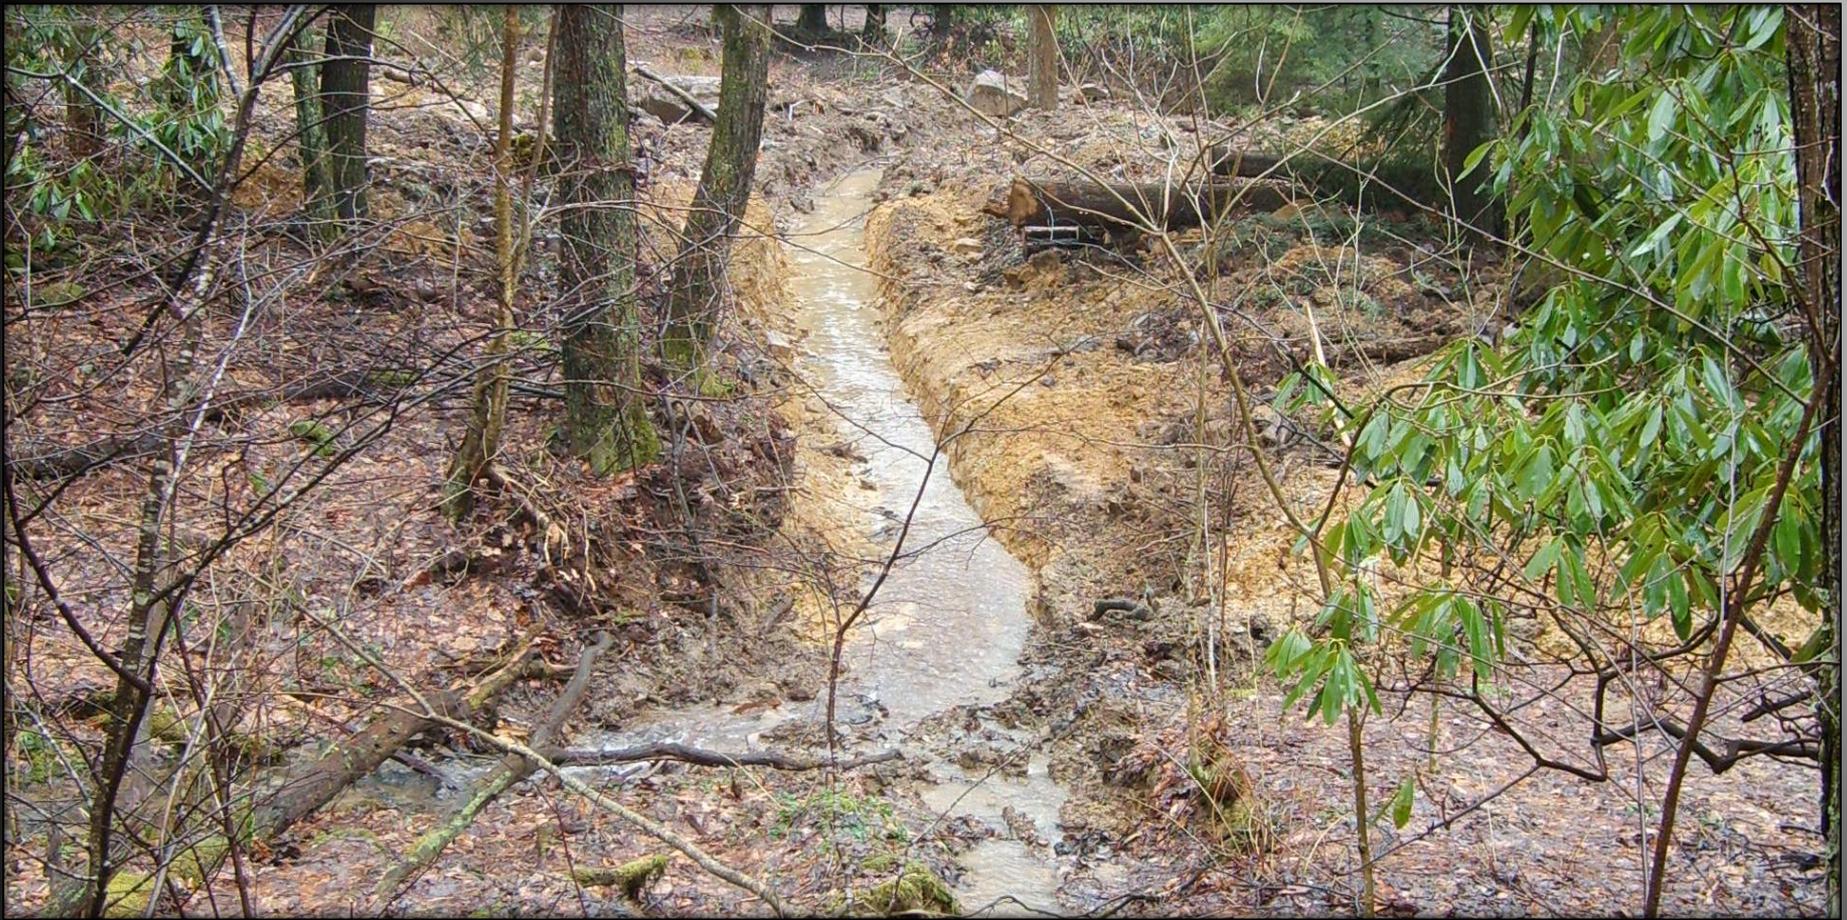
## Stream disturbance >>

Location upstream of marsh, there are two different water supplies that flowed into the Marsh that were diverted into one ditch.

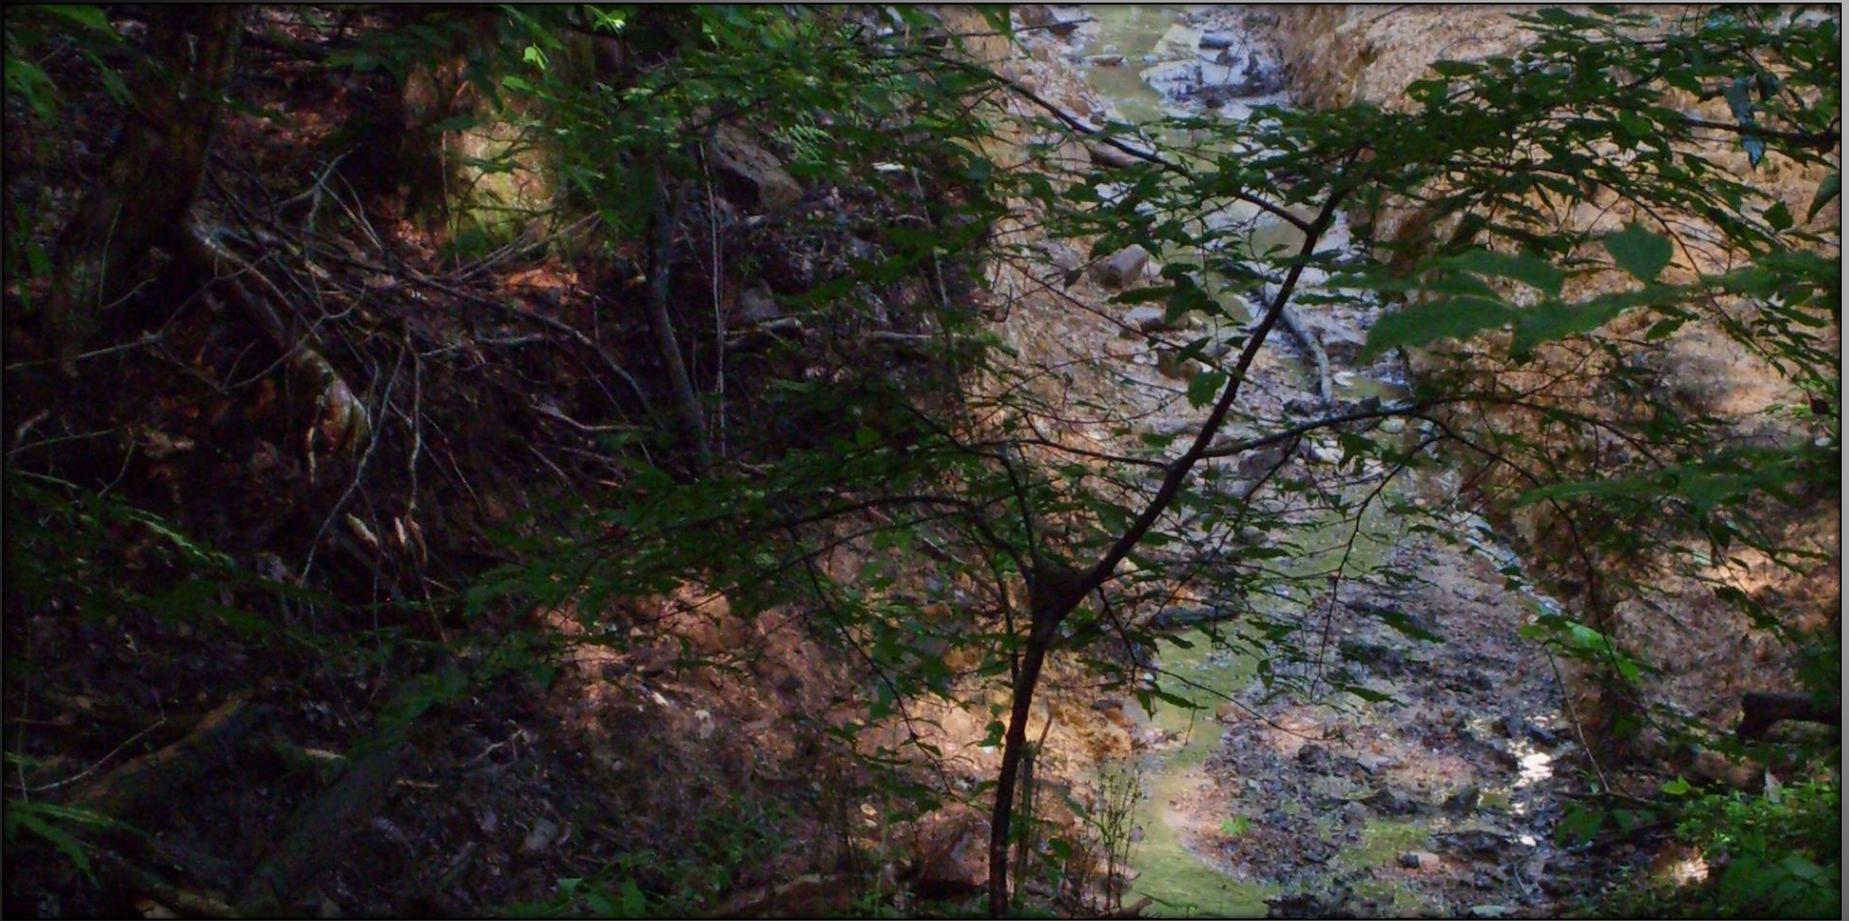
Marsh Water diverted to ditch >>>

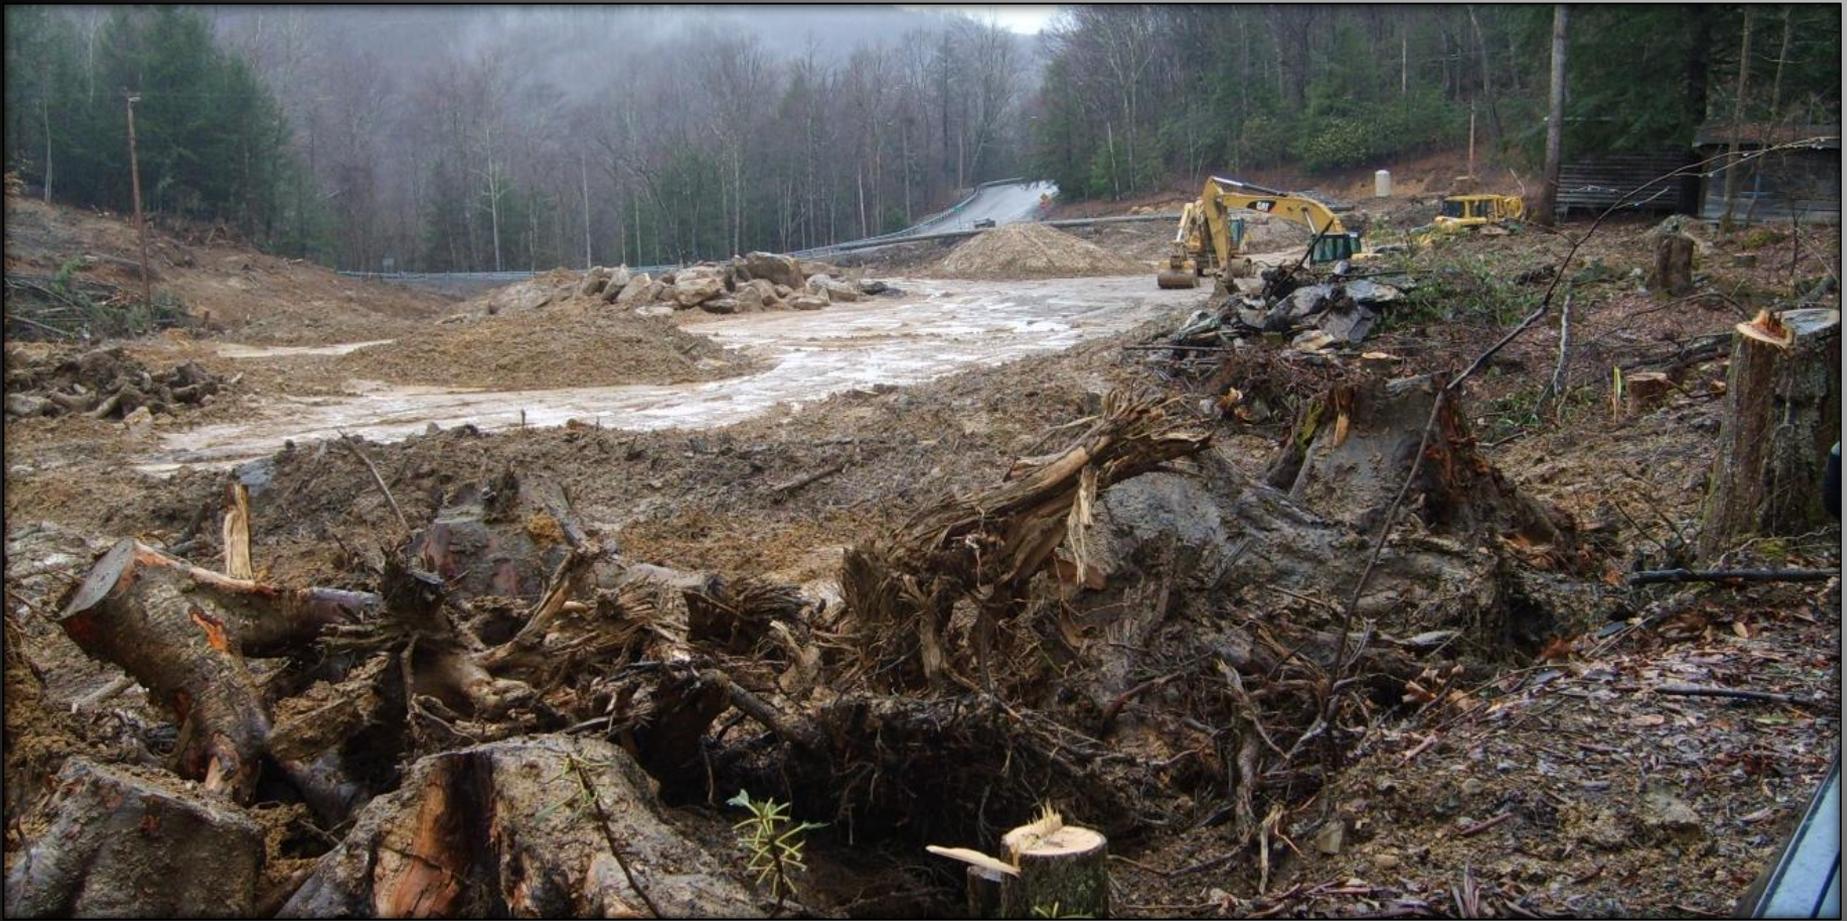
## View from Marsh looking toward RT 20 >>

The Filling has started , the two long steel pipes have been buried from the upper right to the upper left at the drain under RT 20

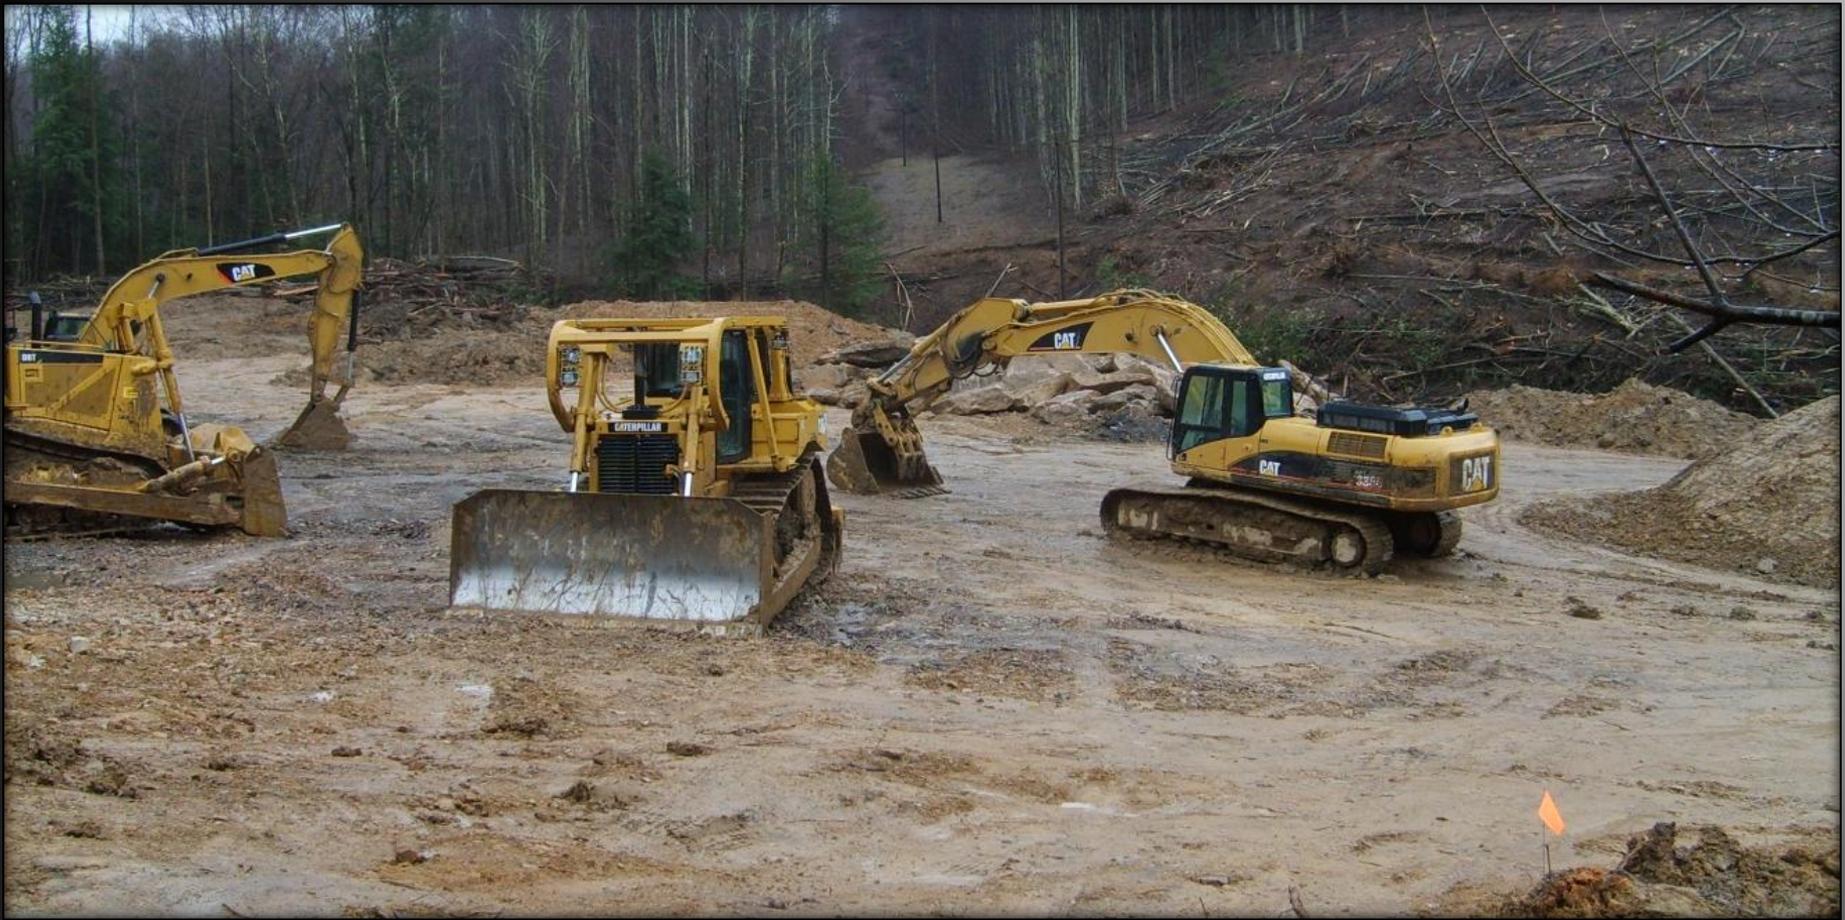
## Ready to fill >>

Note the clear cut in the upper right, this will be the fill after a corrugated pipe is put in below that hill from the marsh to RT 20

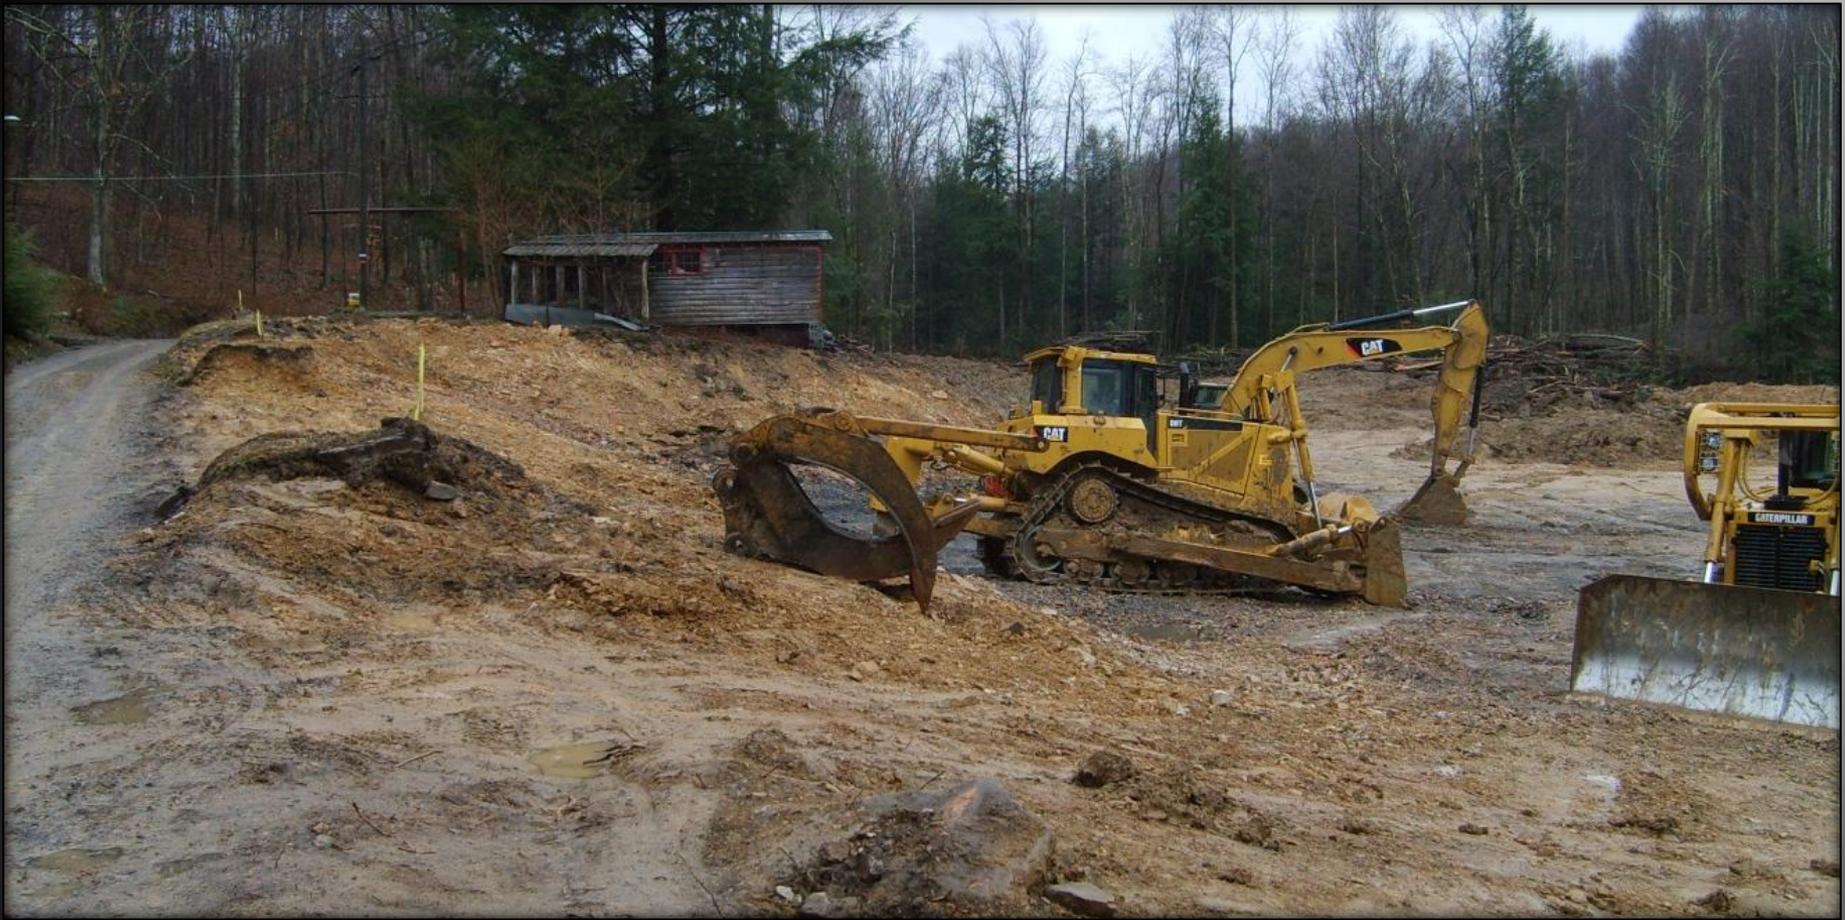
## Just after timber job >>

The gentle slope to the right of the road later became a high wall about 15' from edge of road, you can see a stake there. The marsh and trees are in the upper part of picture. Right behind the out building is a 20' high wall as of today

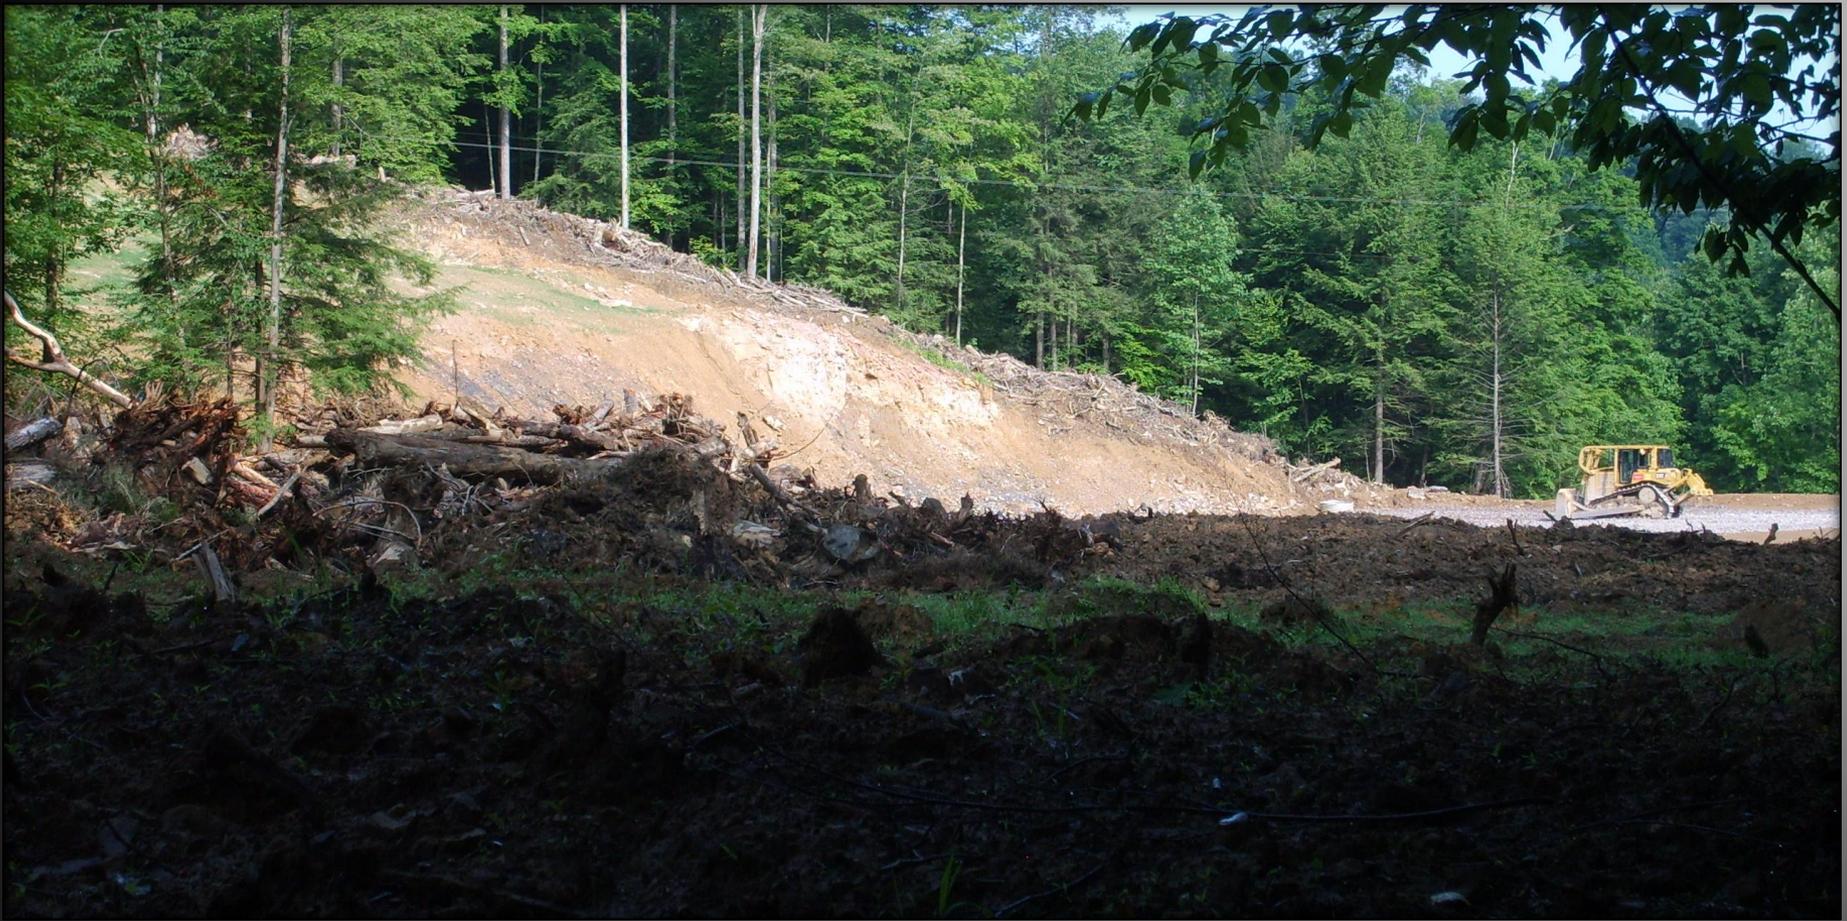
## Fill Material >>

Corrugated pipe from marsh to RT 20 is buried, the stumps removed from hill and the remainder used for fill for the pad

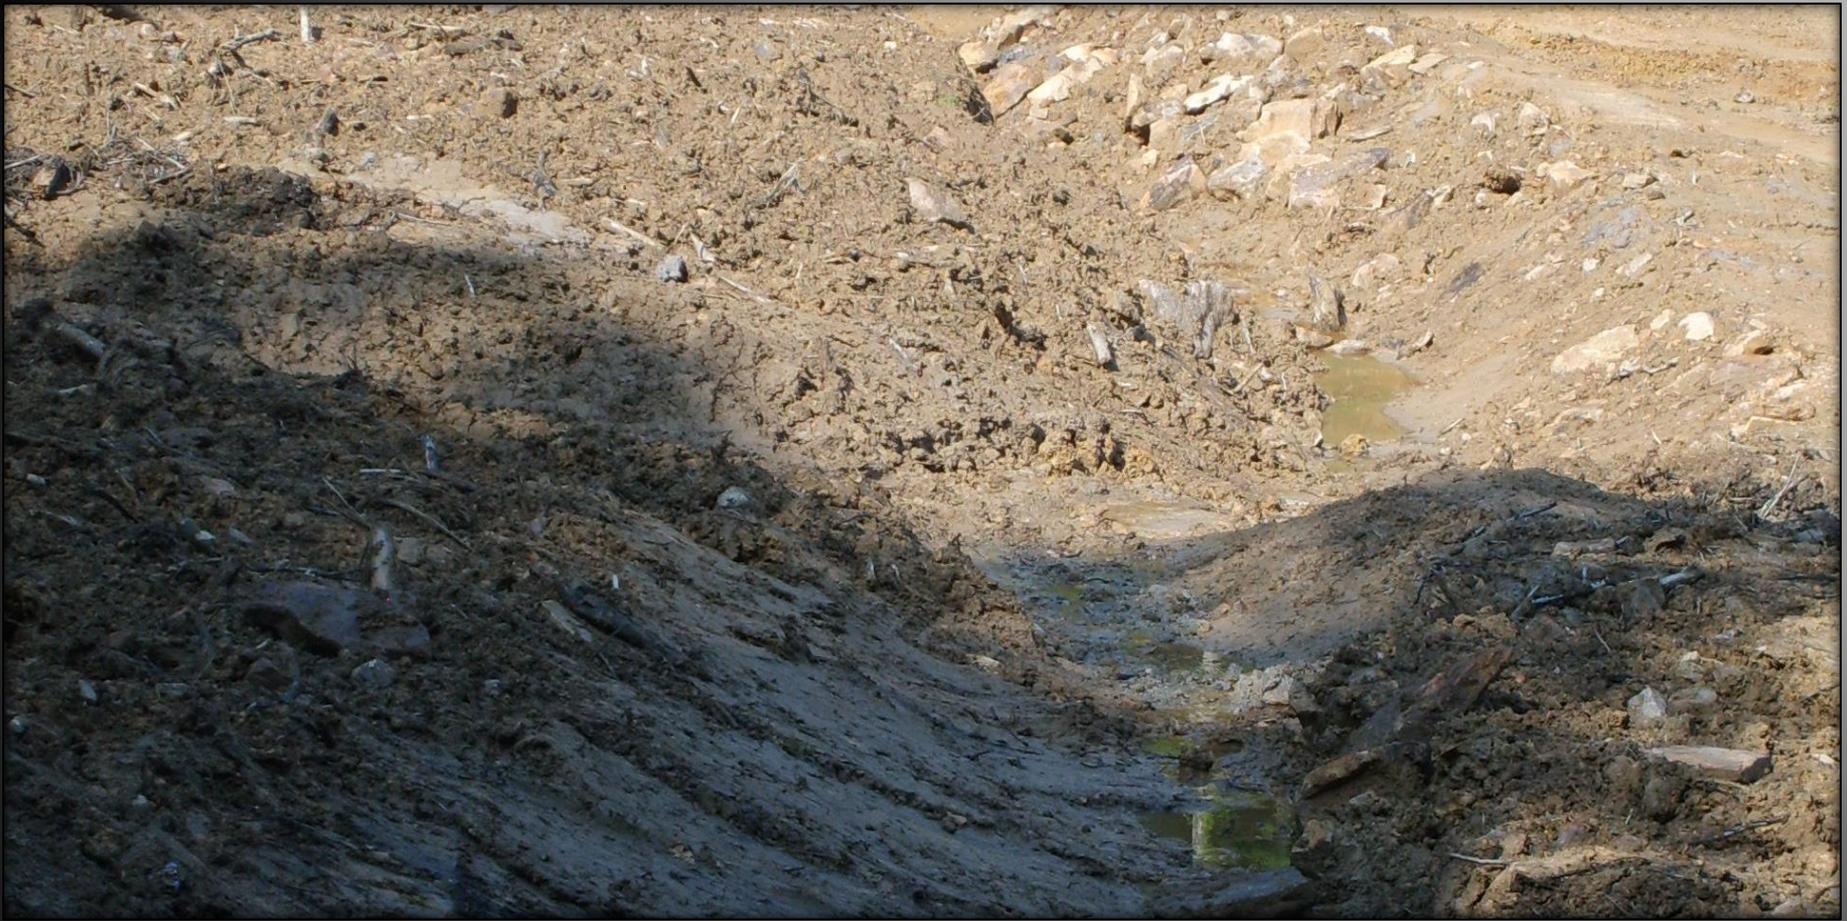
## Marsh water collection ditch >>

All water from the marsh area was diverted to this ditch on the upper part of pad site and sent to the culvert that was installed at base of hill

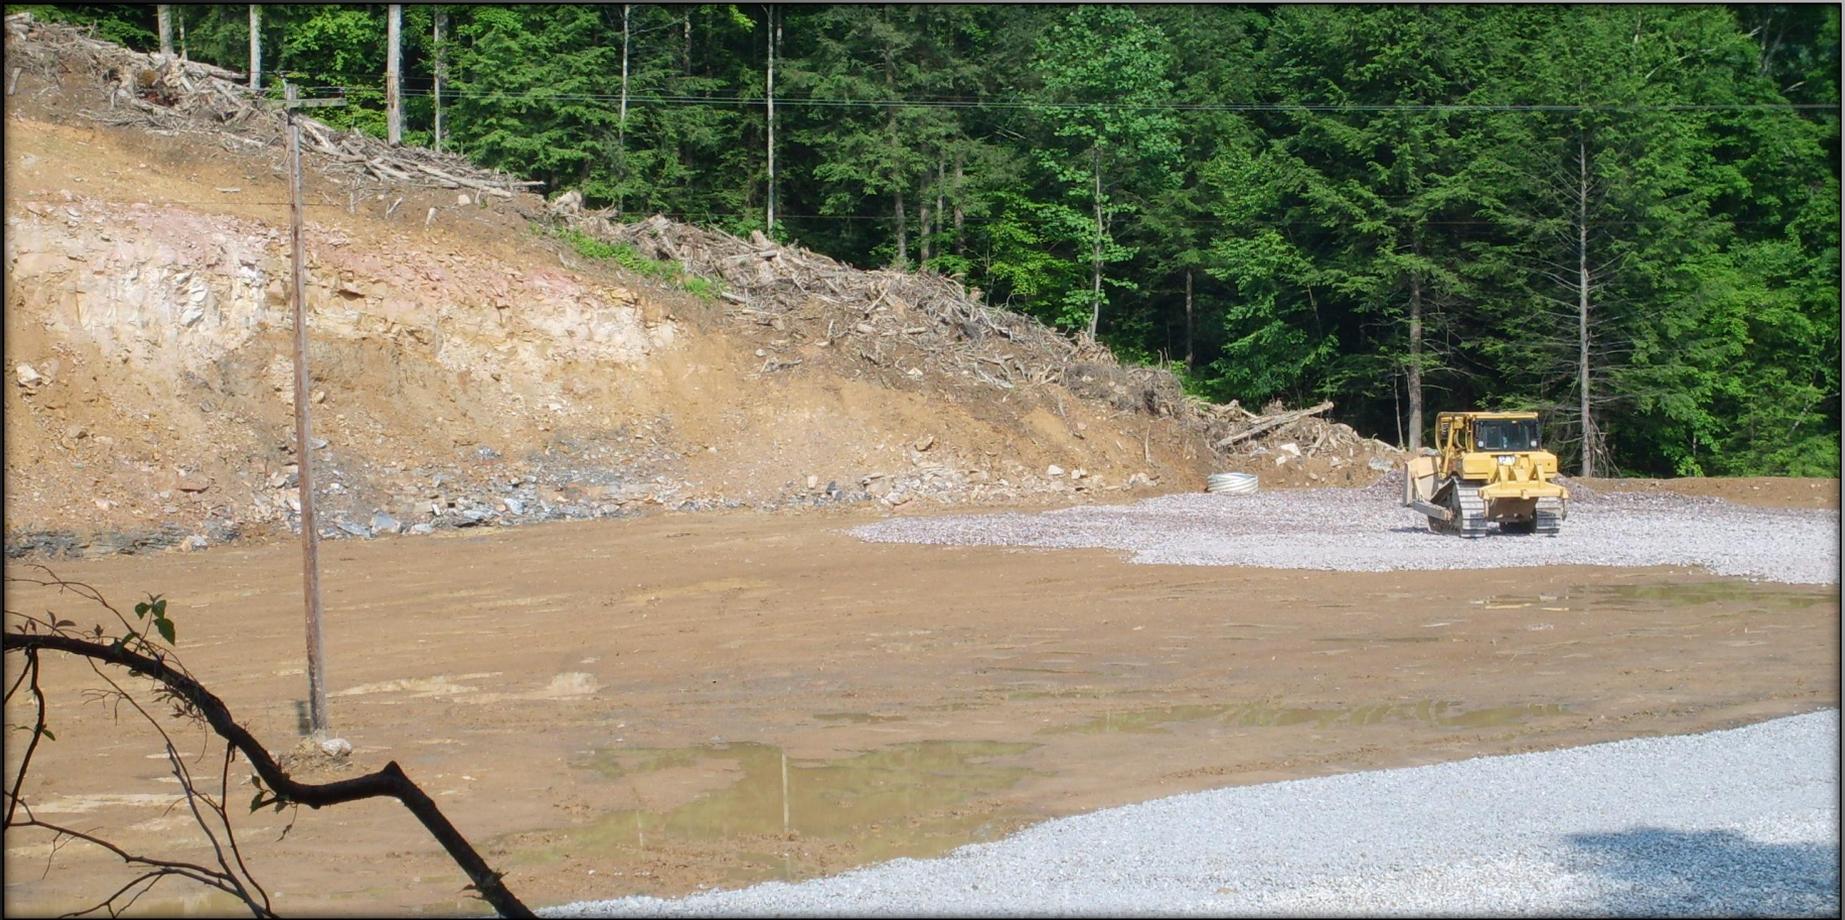
## Finishing the pad >>

,Graveling the pad surface, to the left of the dozer blade by the hill is another culvert that would later catch surface water from the now barren hill. Between the dozer and that pipe would become the road to the water pond on the hill

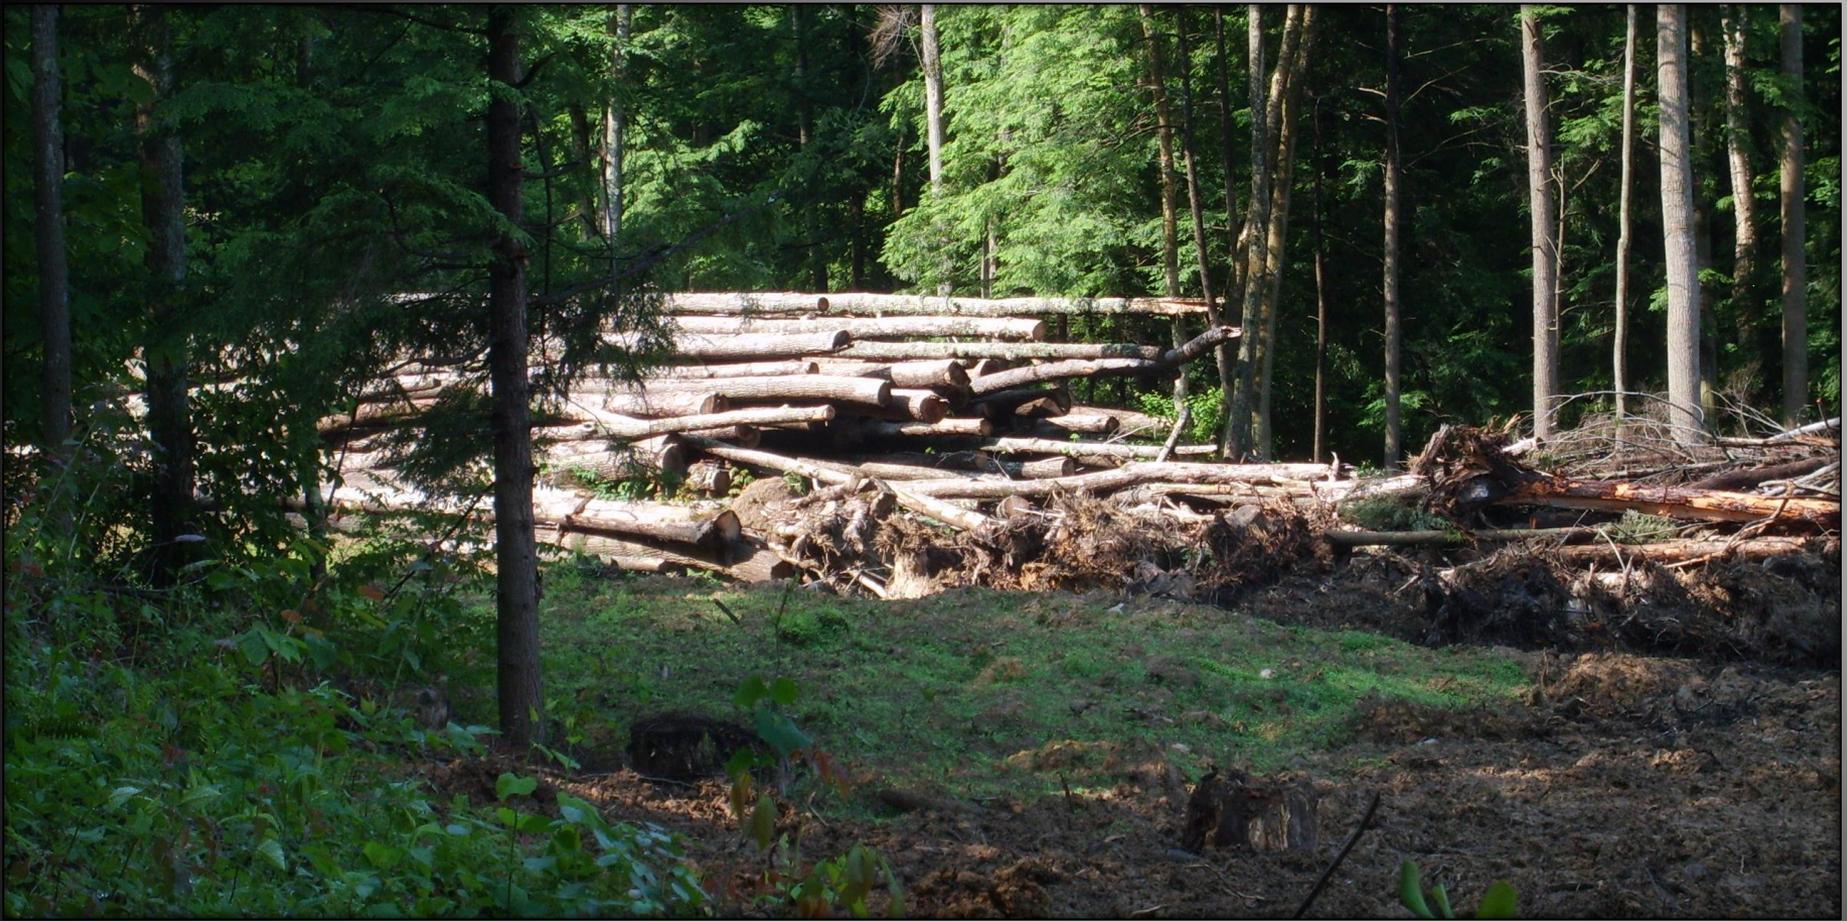
## Rotting Trees >>

No longer marketable or even accessible for fire wood the once majestic trees are left to rot
