# TALL TREES WELL SITE

API# 97-03707

Site preparation from beginning  
To well production

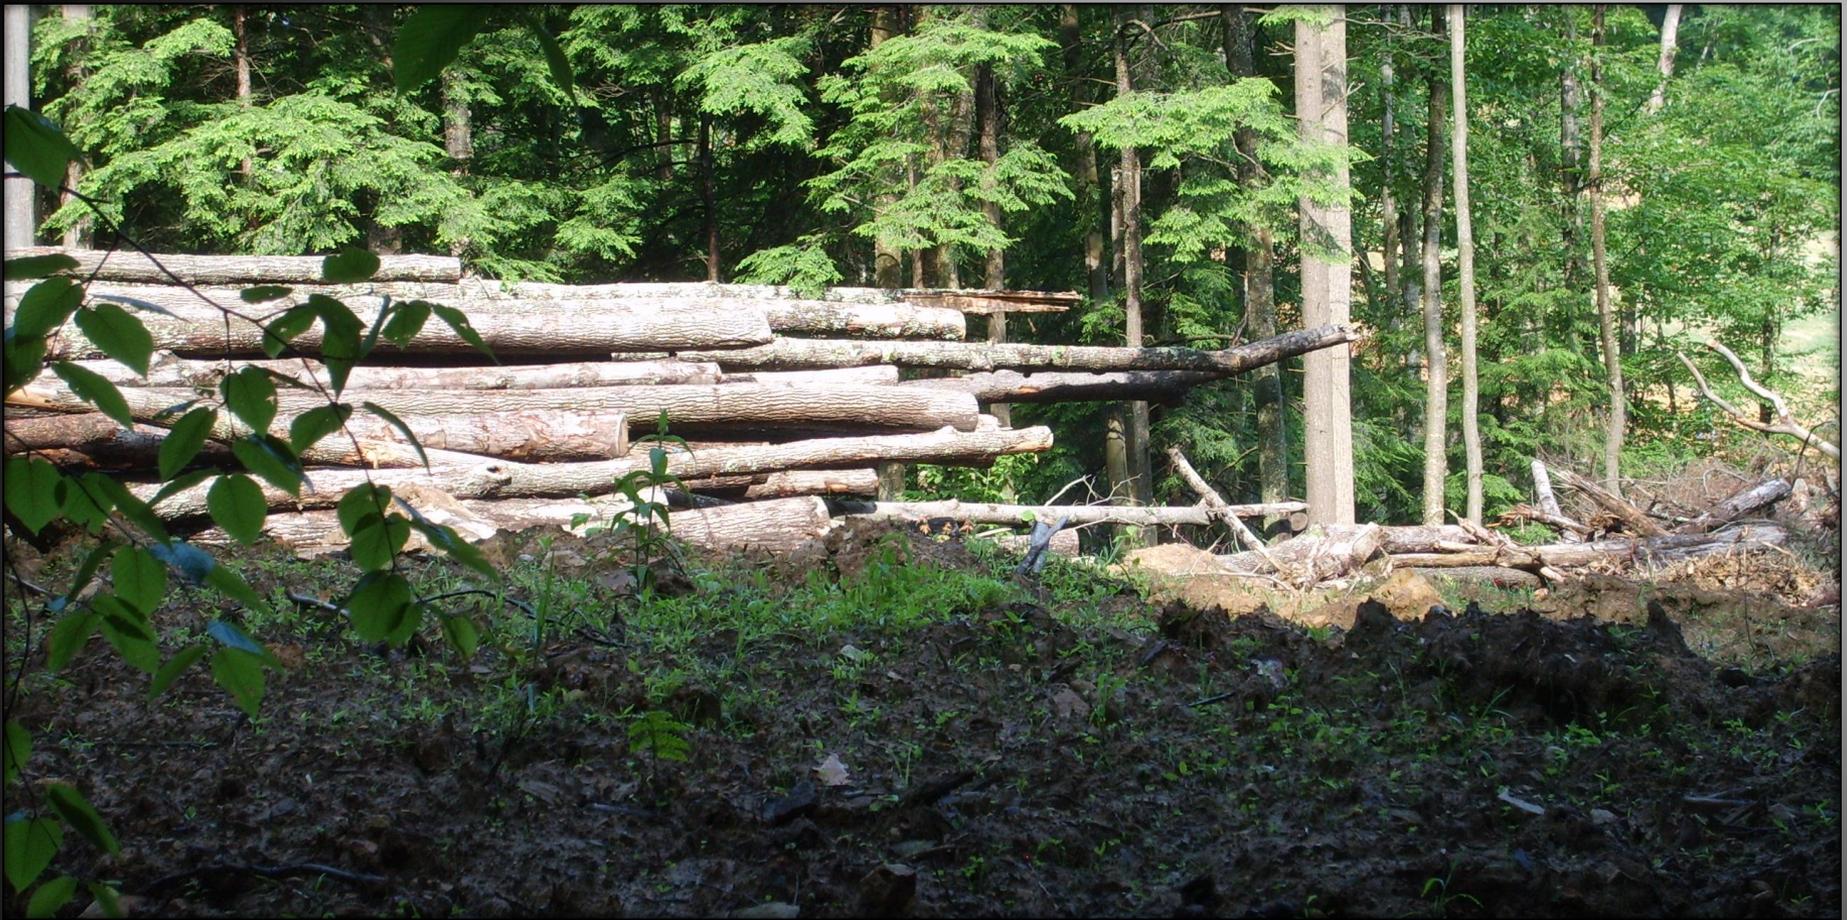
## Left to Rot >>

Marsh between trees and road, no way to get them out they are left

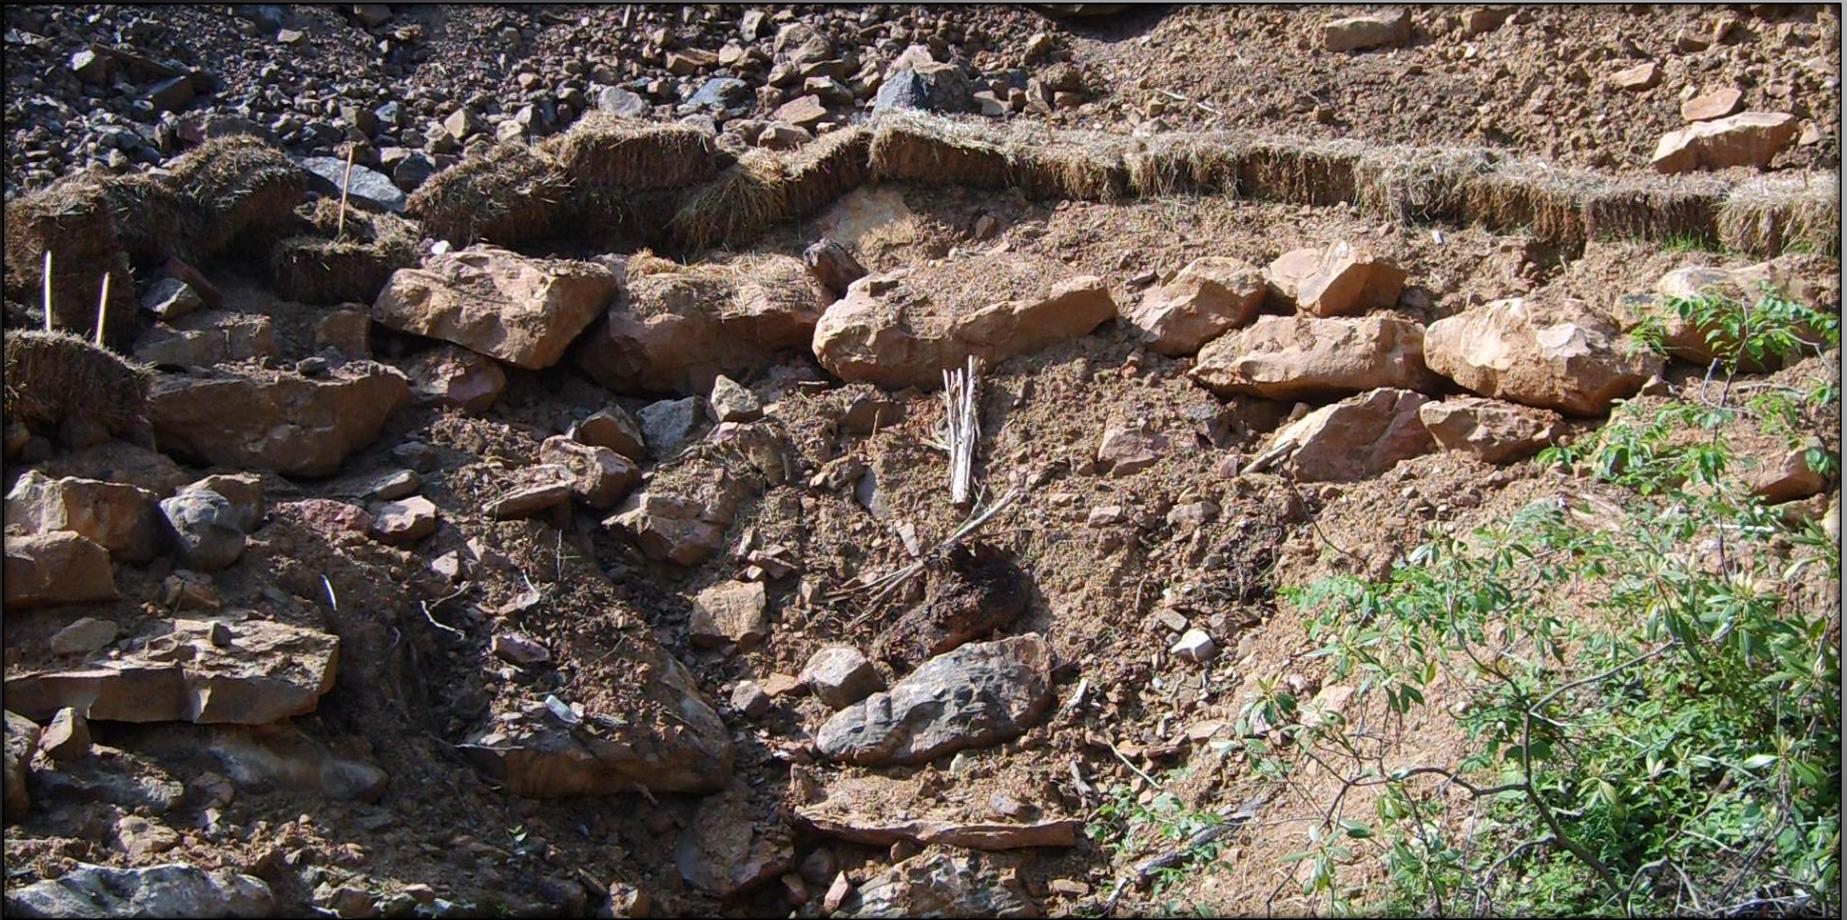
## Fill along RT 20 >>

At bottom of picture are the two pipes that are seen in the prior picture

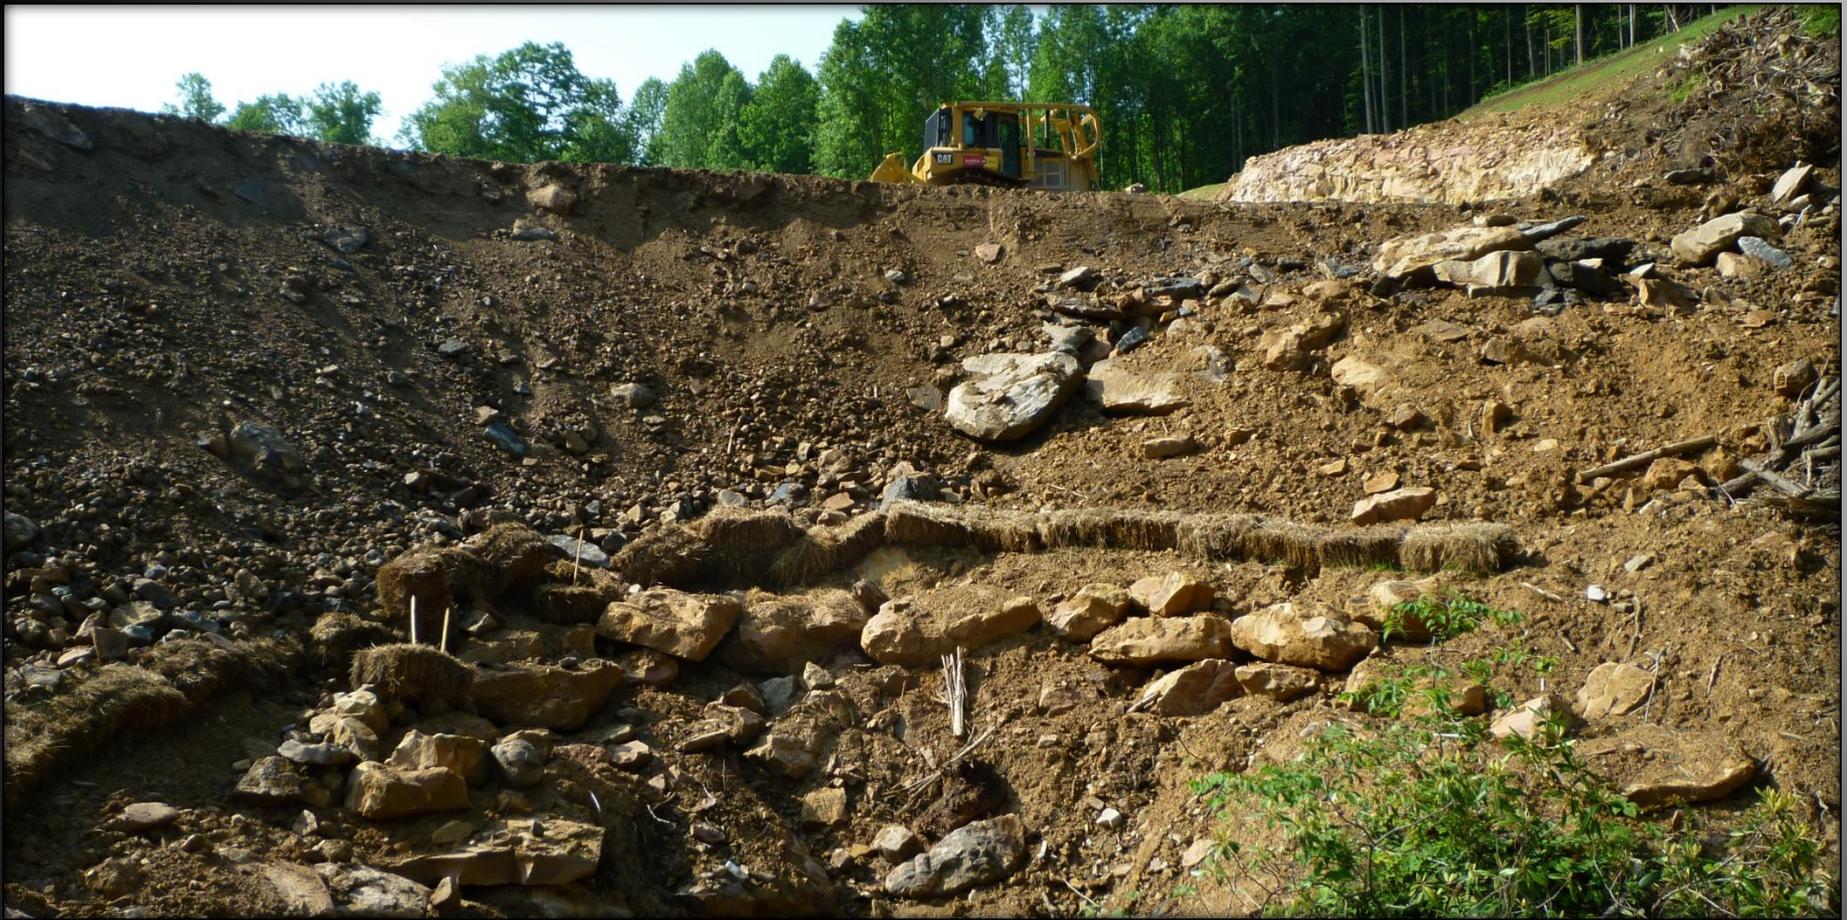
## What was filled >>

A good perspective of the amount of fill that was used to build the pad site. The dozer at the top of the hill is about 12' tall. Also note the hill extended to just about the back of the machine before the hill was torn apart for fill, they chopped away to get the size pad and left that high wall.

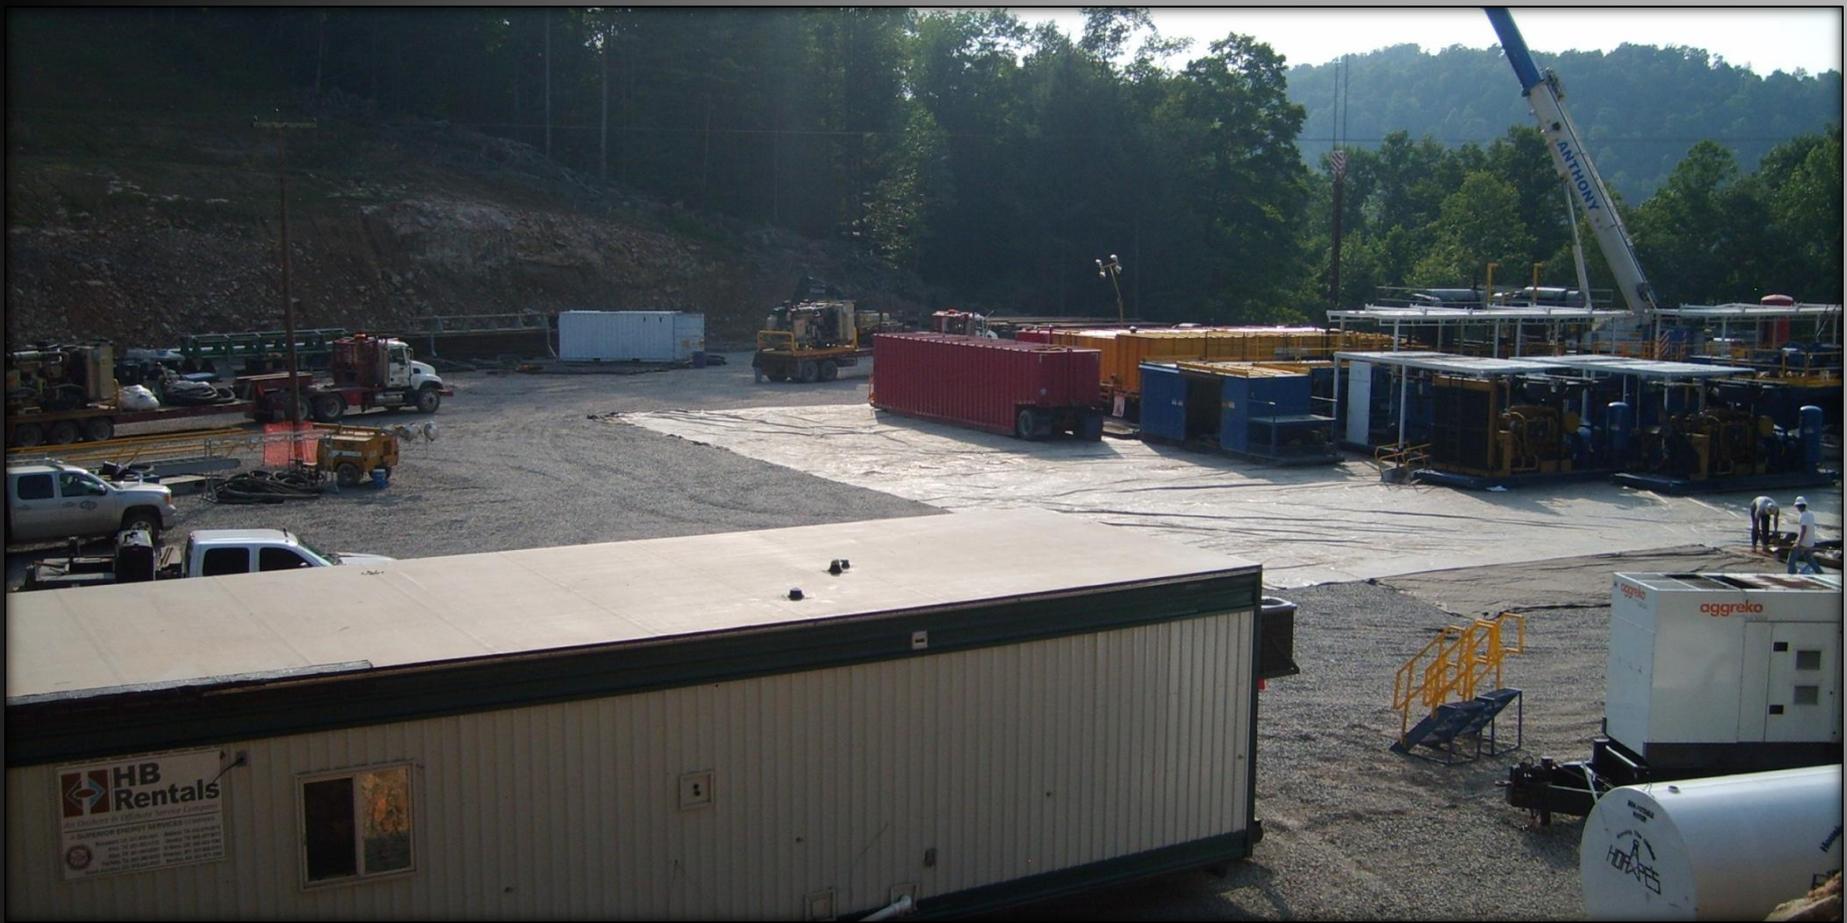
## More Equipment need to support drilling >>

Note rubber sheet under equipment, it was later built up around the edges to contain any spills that happed in that area

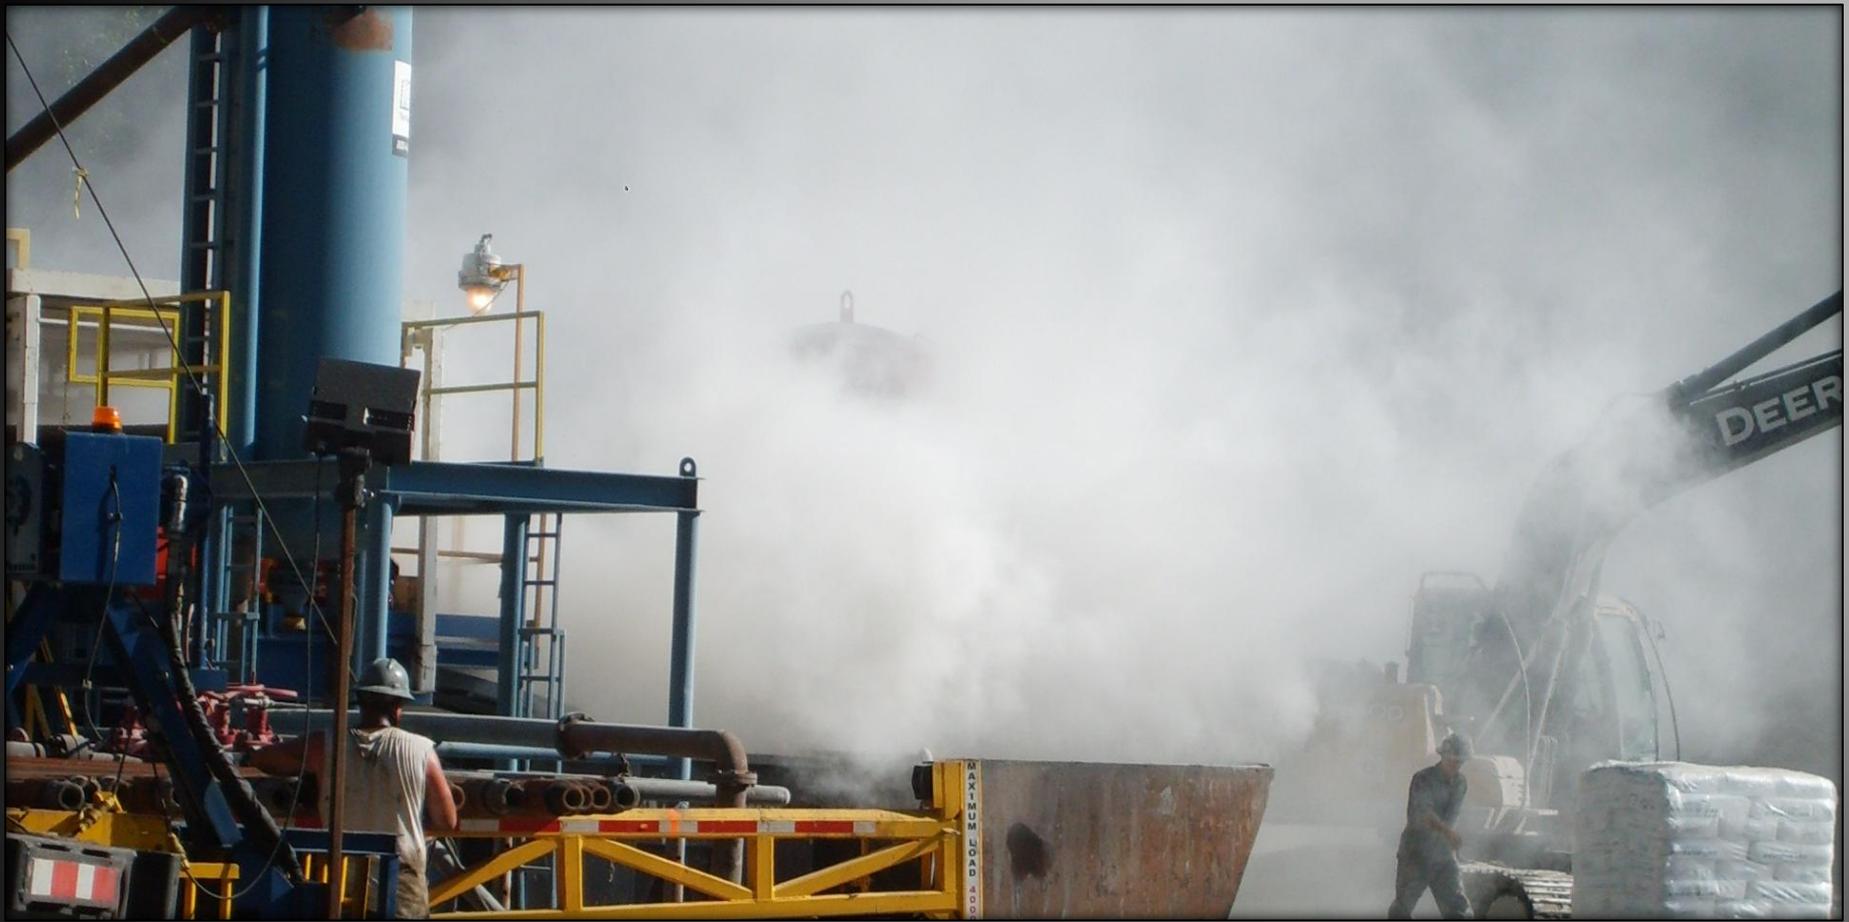
## Safety First >>

Don't know what the different materials are, but it sure can't be safe to breath.  
The backhoe operator is in the thick of it

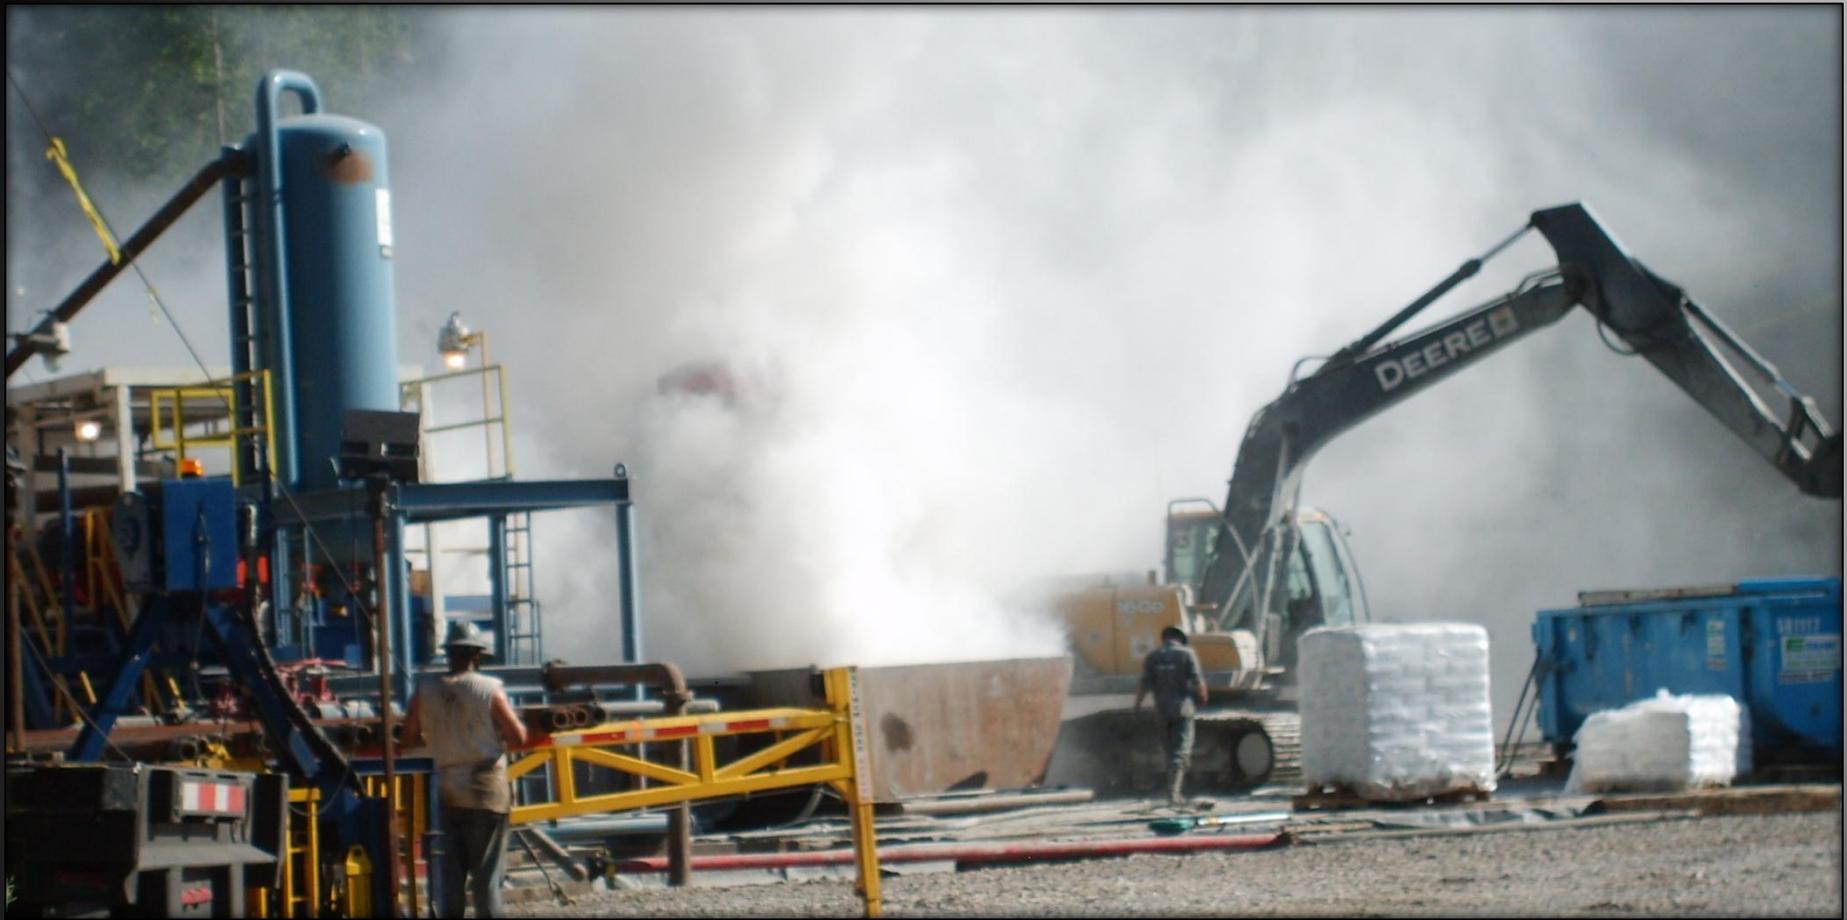
## Where's OSHA >>

The window in the backhoe was open. The pallet of material being mixed is to the right of the guy walking

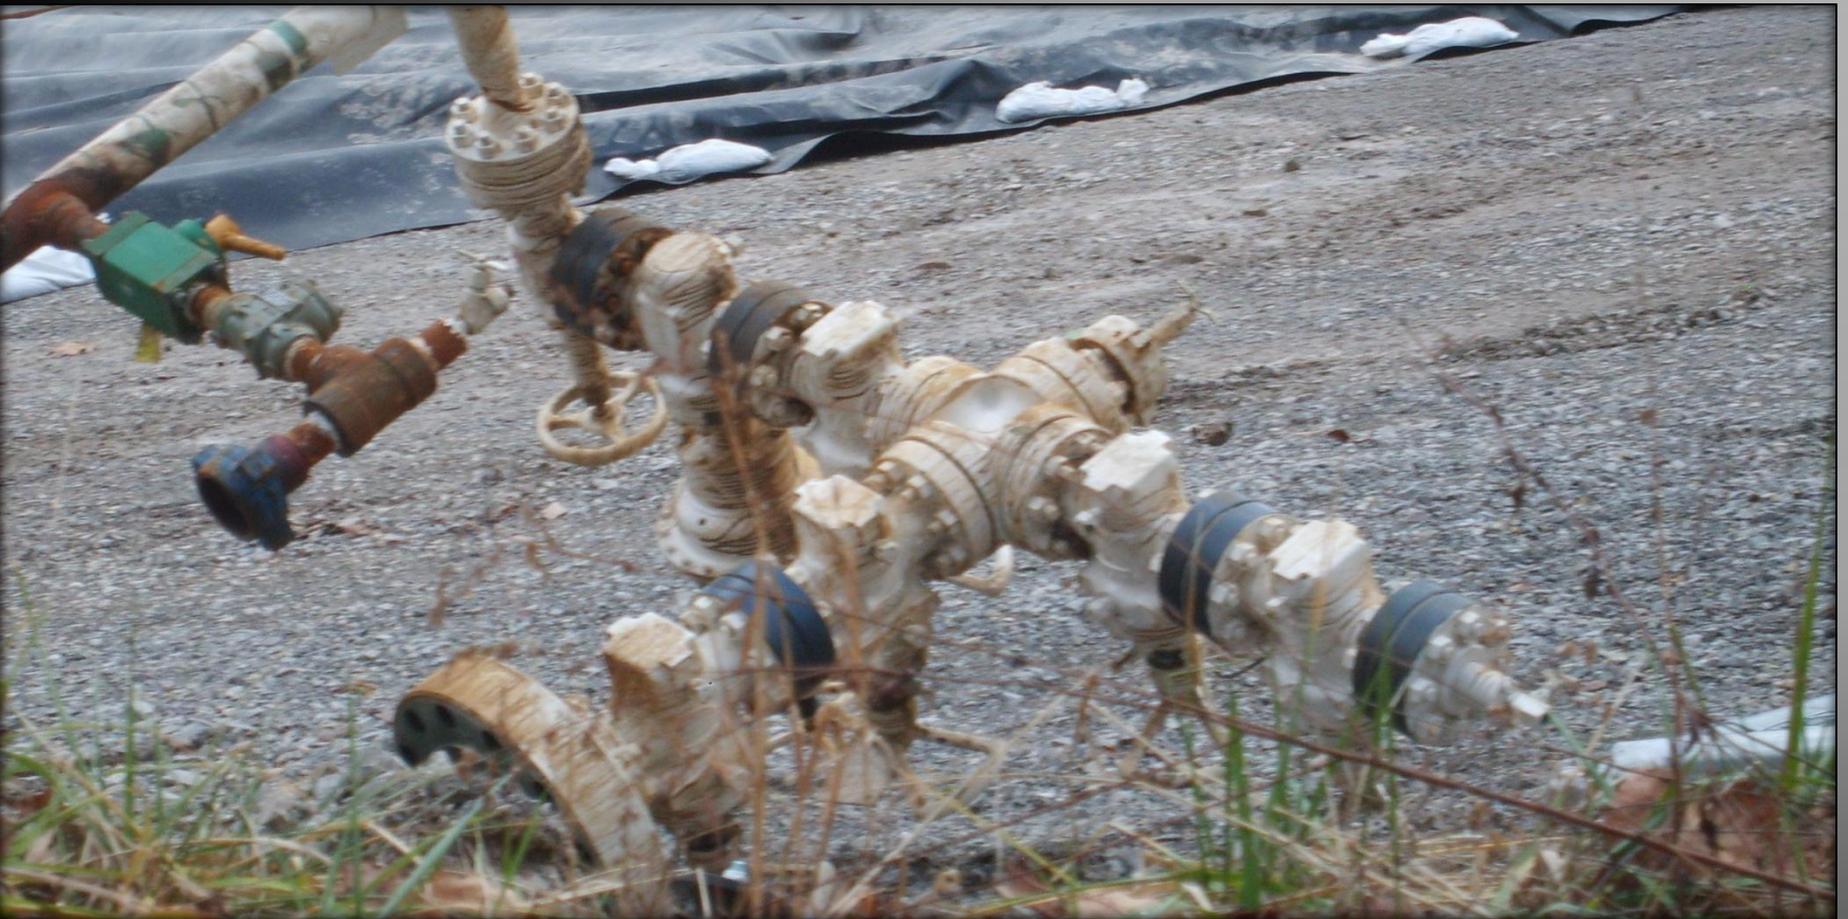
## Well Head Frack Unit >>

This is what was used months before to cap the fracked well. Note the rusting that has taken place in that amount of time from produced water coming up to the surface.

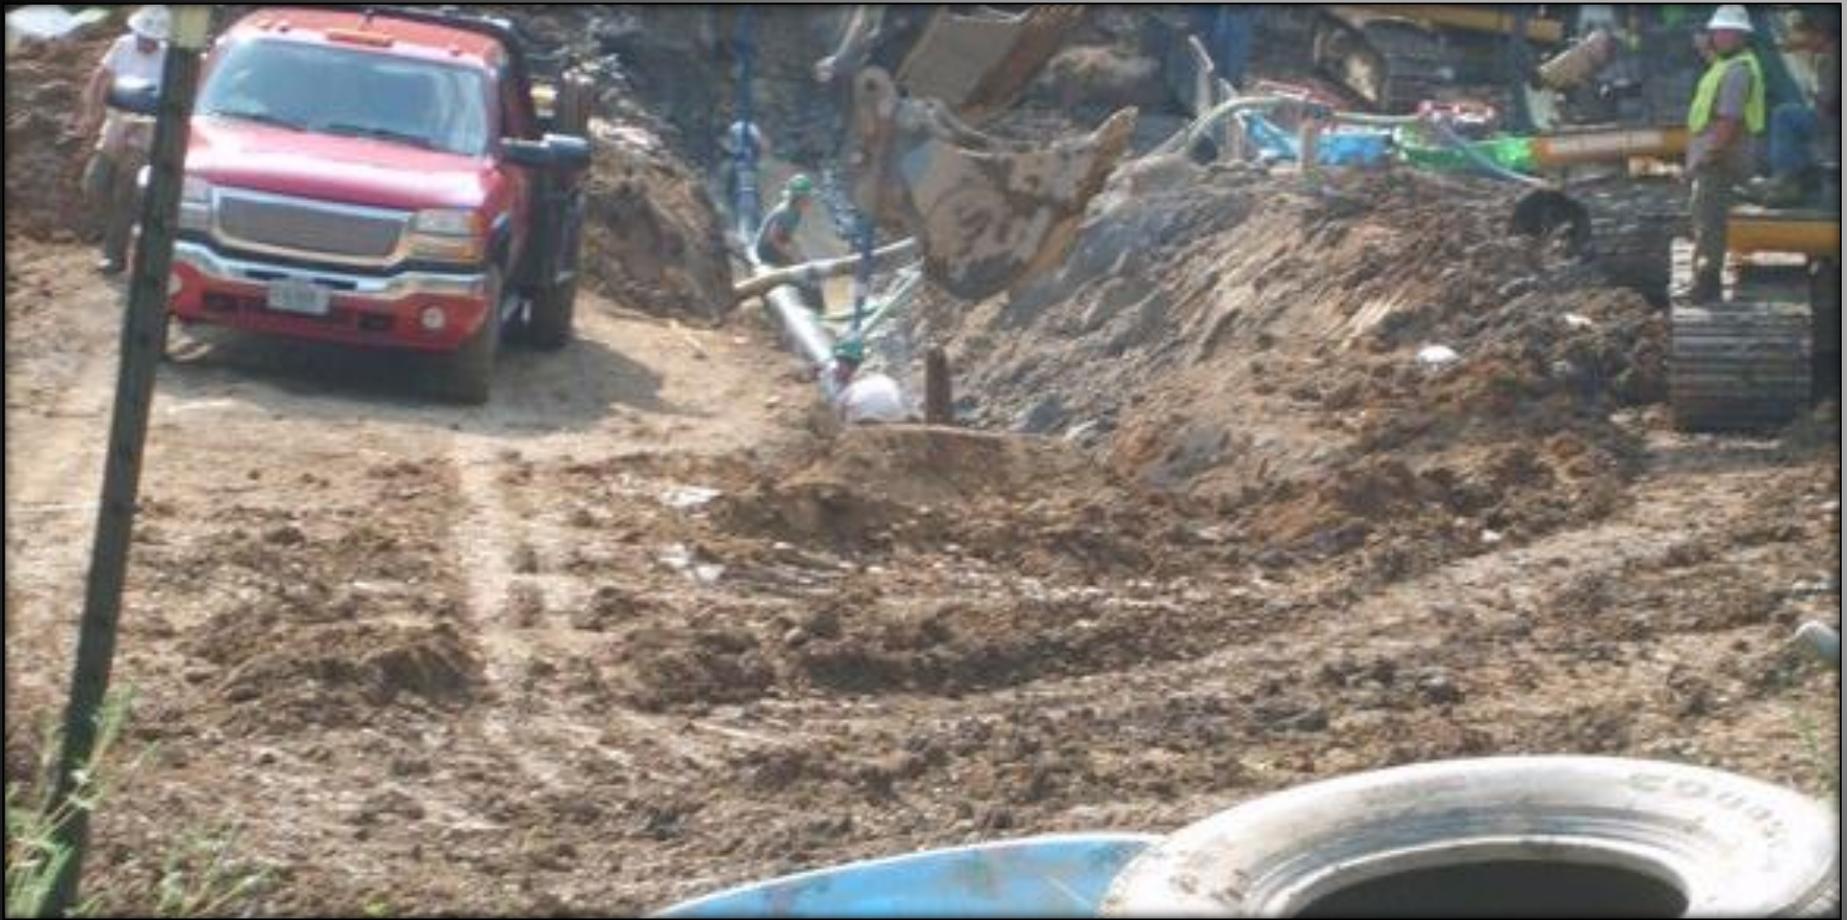
## Tall Trees gathering pipeline >>

Laurel Run Creek crossing Gaines Rd just off RT 20 the worker in the bottom of the ditch is below creek level, the pipe next to him is carrying the creek water via pump from upstream to down stream. The contractor got sited for muddy water.

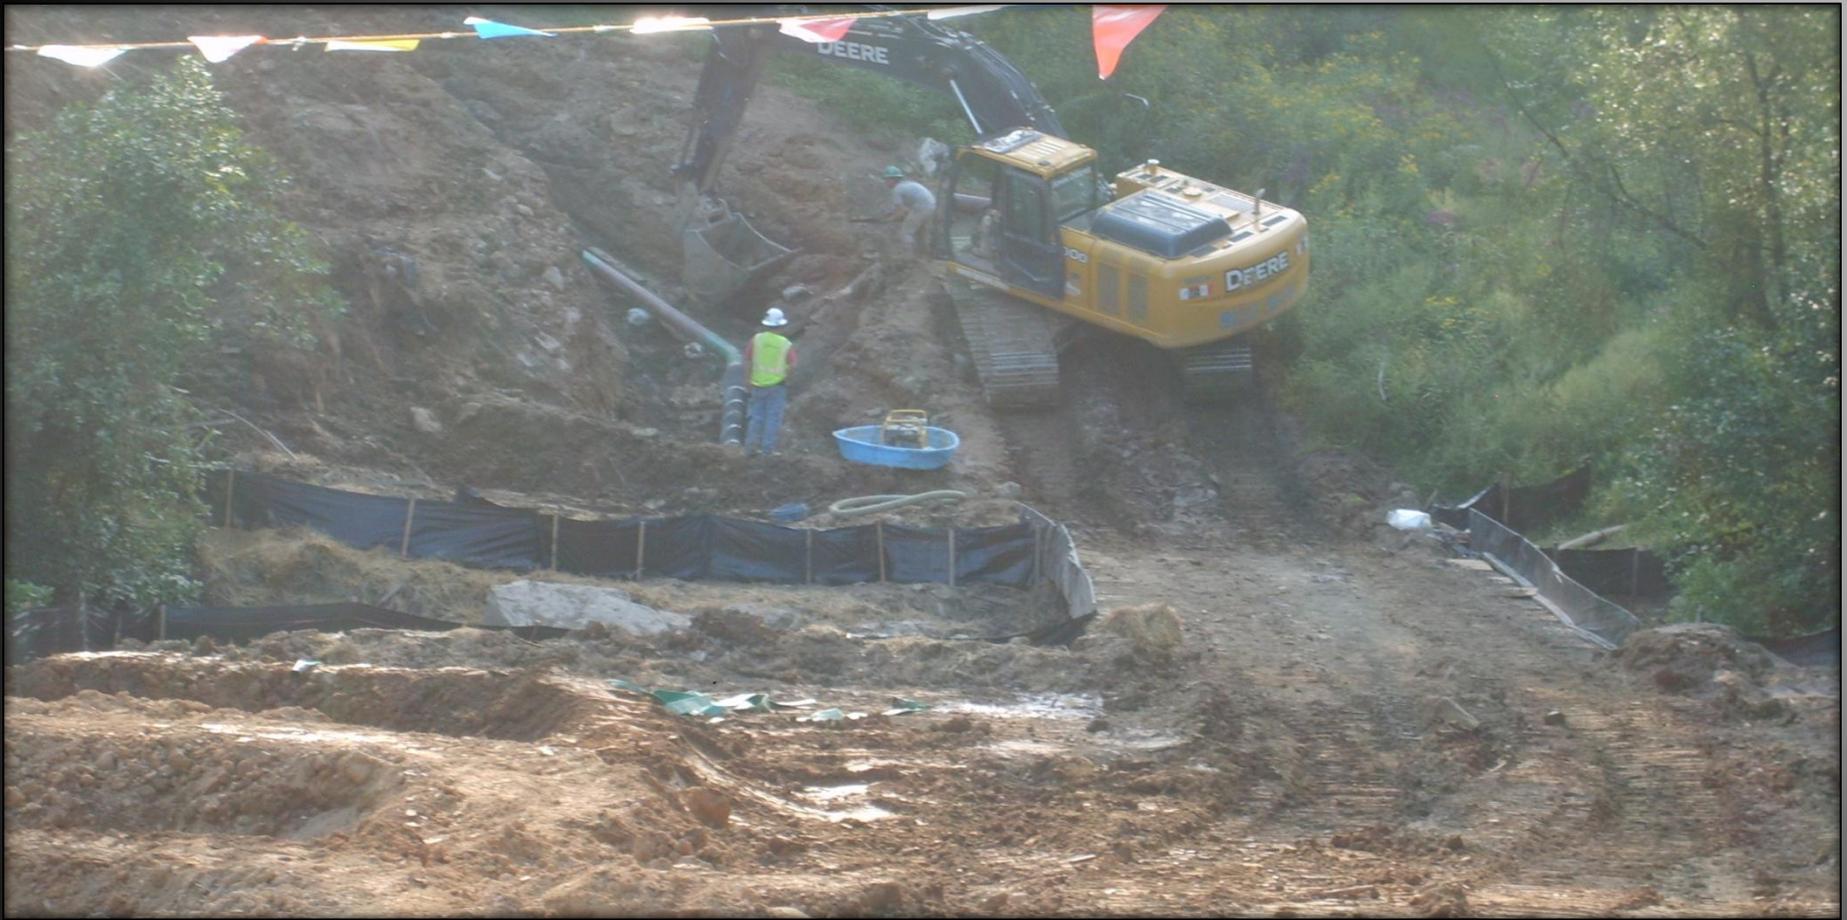
## Laurel Run Creek Crossing >>

Crossing the creek with a temporary bridge, just below the silt fence is the creek with the pipeline now under the creek bed.

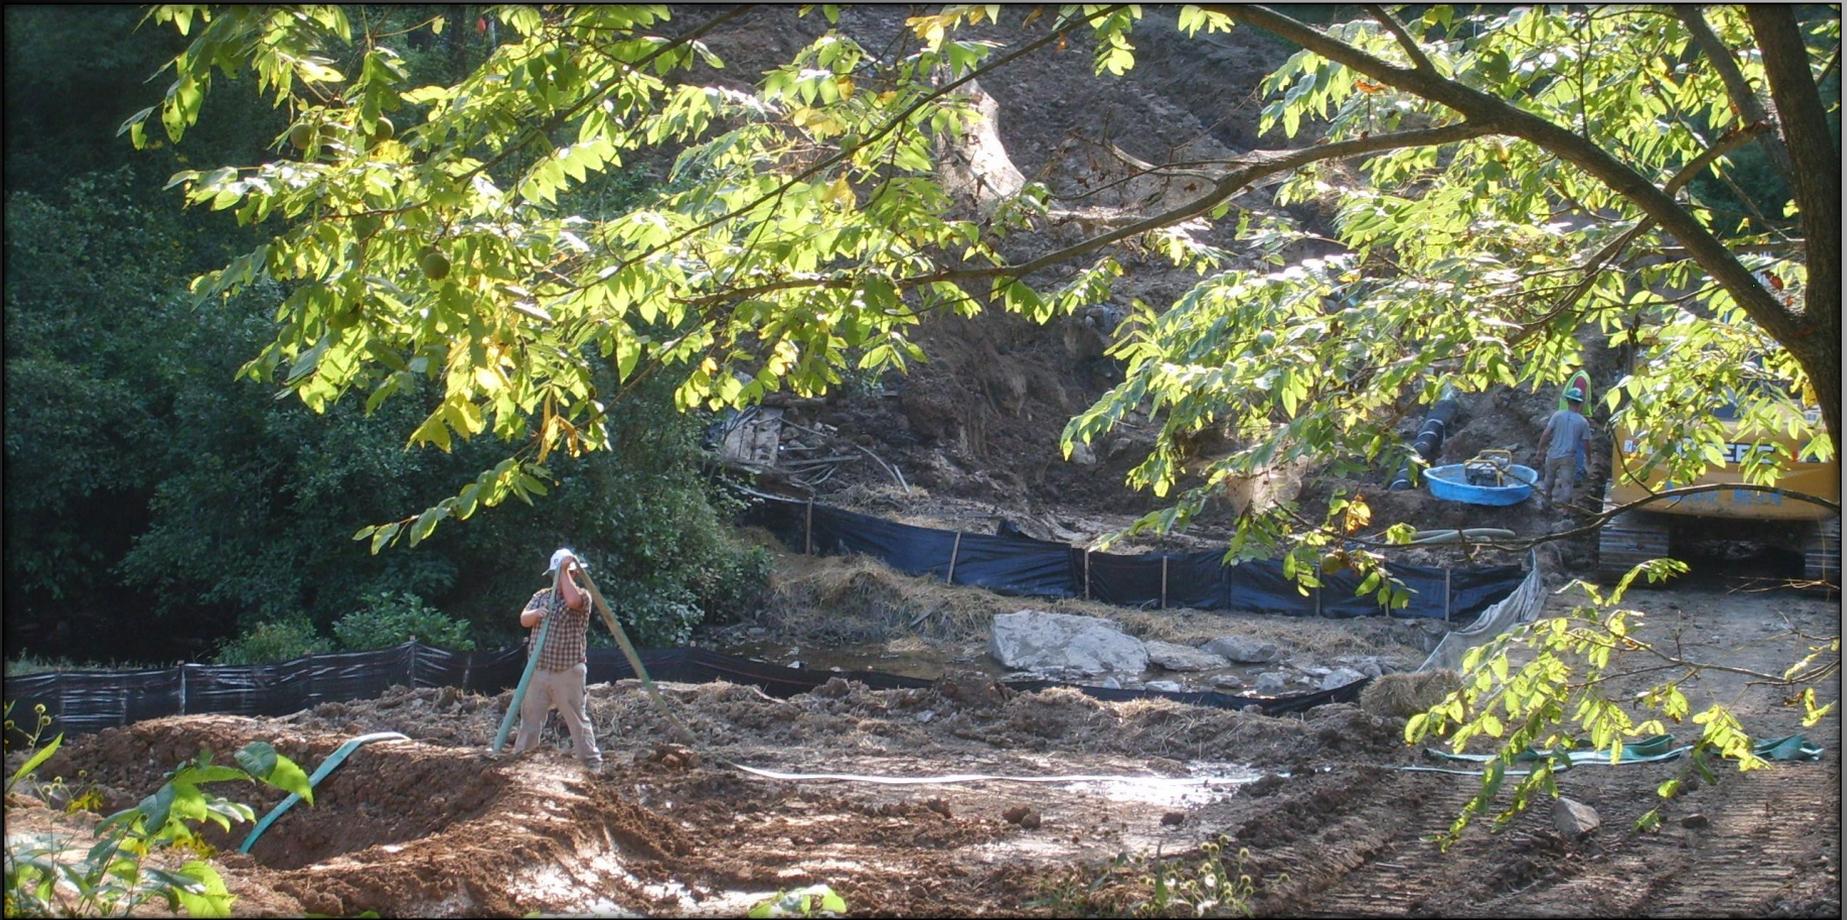
## Laurel Run Creek Crossing >>

Silt fence now installed on both sides of creek
